# Caribou Police Department

## Assessment

In January of 2020, the City of Caribou, Maine contracted with Artifex Architects and Engineers and with Public Safety Consulting Architect, Manns Woodward Studios (MWS) to perform a comprehensive assessment for the Caribou Police department. The scope of work addressed three primary areas of focus:

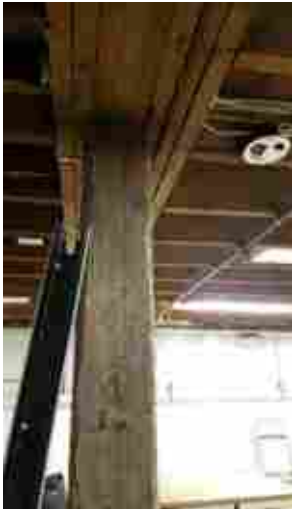
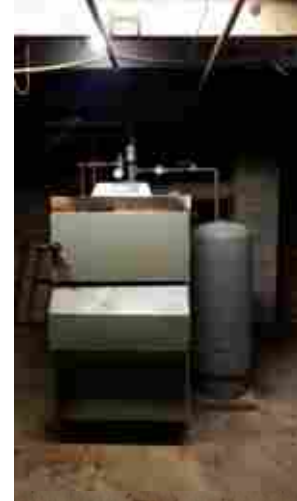
In general the deficiencies in structure would not align well with its usage as police facility, beginning with its inability to meet Category IV construction standards. The building, a single-story masonry structure with a flat roof has a full basement. The structure for the first floor is made up of 2"x12" floor joists, spanning from eighteen to twenty-six feet depending on the bay, cut to hang from composite beams created by gang nailing six 2"x12" with a 2"x4" cleat on each side. These beams spanned to 12"x12" wood posts of indeterminate age at approximately eighteen feet on center. There was no lateral support for the columns in any direction and no mechanical connection of columns to beams.

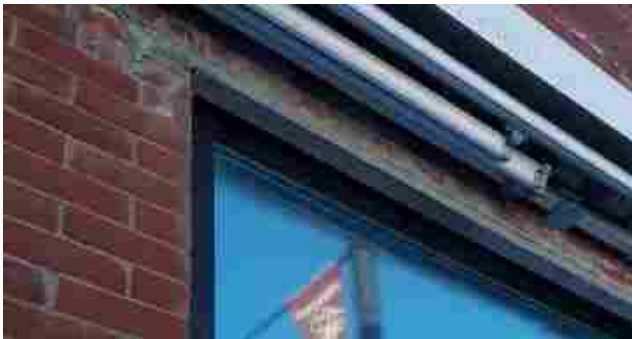
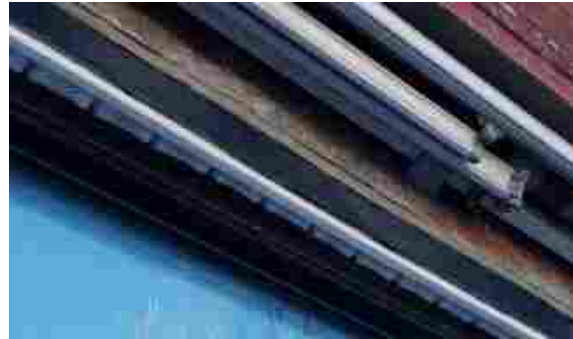
The front windows are commercial storefront with double-glazed glass. The aluminum is in generally good condition, but the masonry surrounding is in poor condition and small ad hoc details have been made to maintain a generally acceptable appearance.

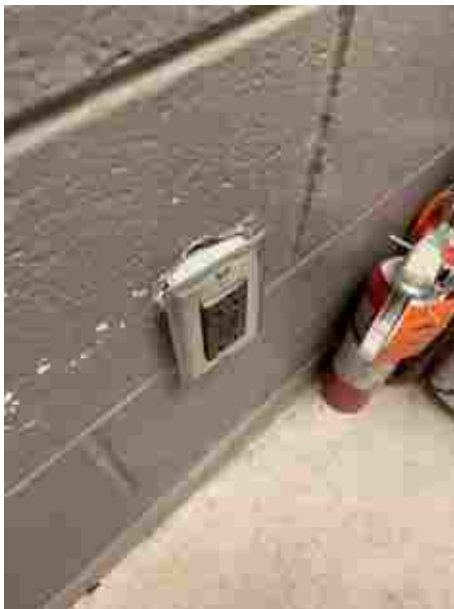
- Compliant: no deficient equipment noticed during visit (not many in view due to amount of property)
- One in dispatch area is loose in wall

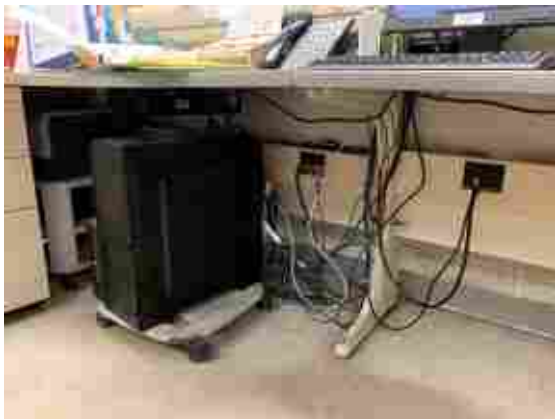
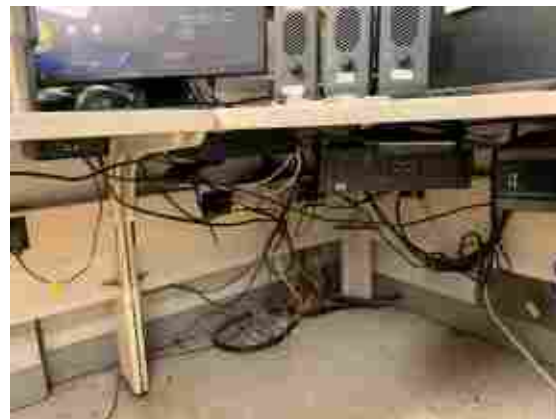
Photos of under desk wiring in dispatch:

Wiring supported and protected from damage

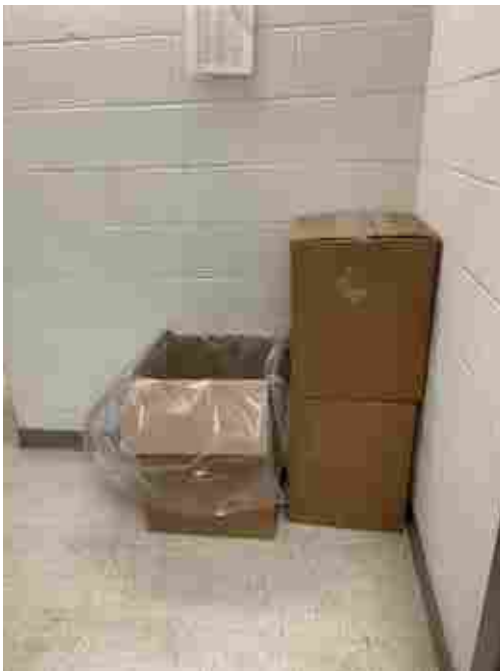
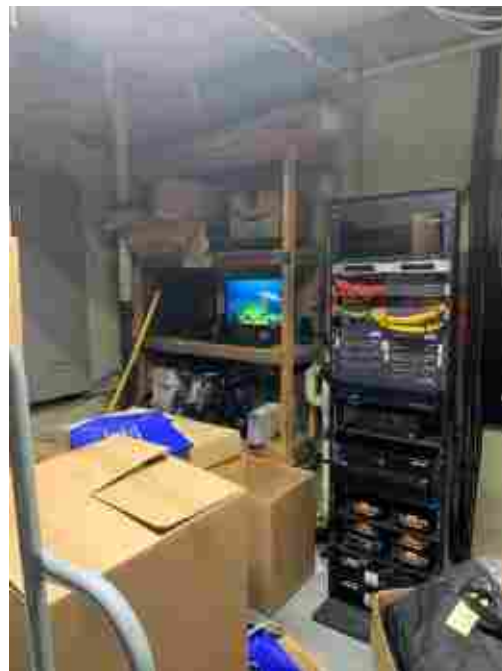
Photos of storage areas:

- Furnace / boiler room not viewed during visit
- All rooms are used for storage due to lack of proper space for operation of police department.
- Private offices were not photographed due to the confidential nature of the business conducted in the police department. Those areas too are used for storage. In some rooms, boxes and other items must be moved to access file storage.

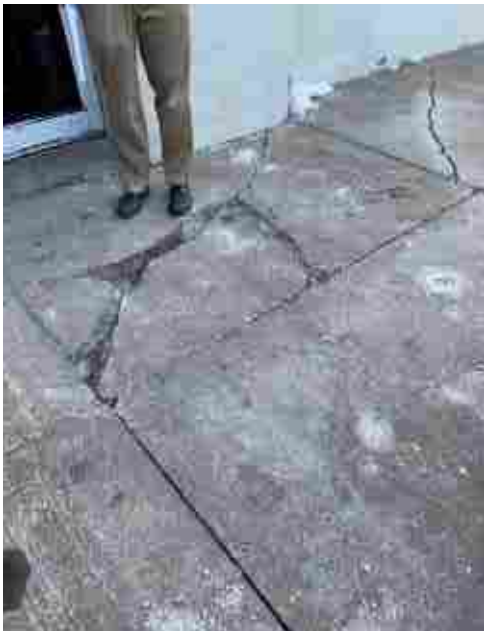
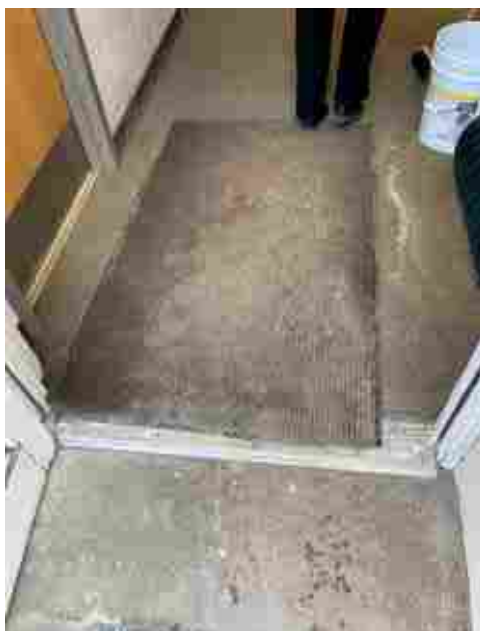
Photos of front discharge area:

- Safety hazards exist when exiting each door
  - Front Door – uneven surface on sidewalk, rug not regularly replaced (trip hazards)
  - Rear door – rugs not regularly replaced, ill fitting; brick material regularly falls from building and hose tower with potential to hit employees
    - Update: On 3/20/2019, fuel delivery person reported a “near miss” with a falling brick
- Door in detached garage not usable during inspection
  - Update: Replaced 3/20/2019

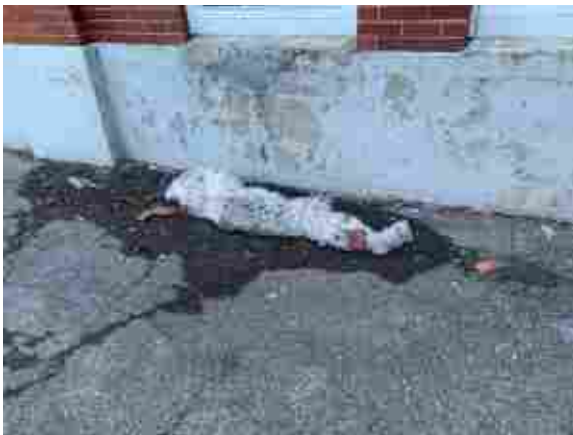
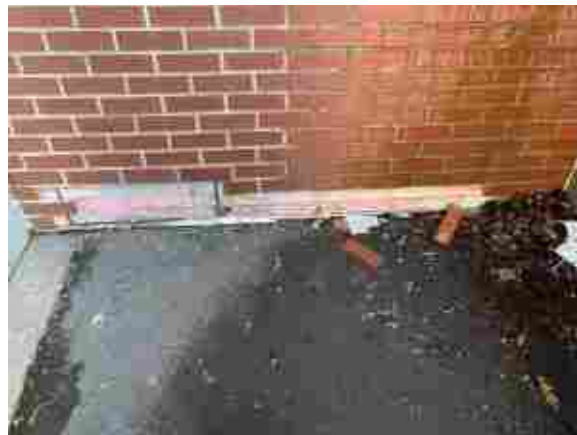
Debris falling from building and hose tower:

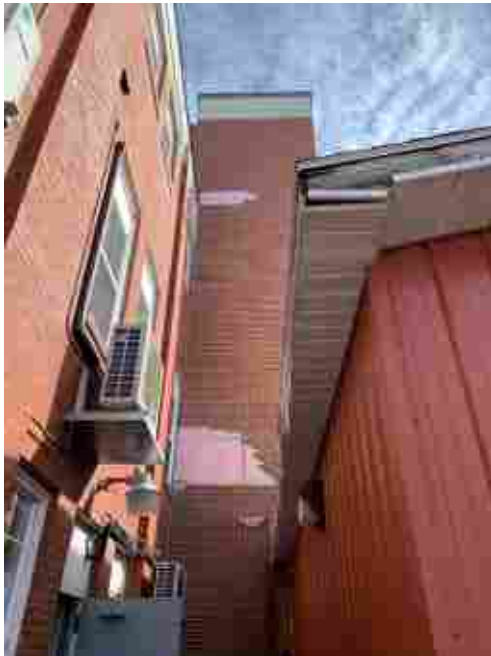
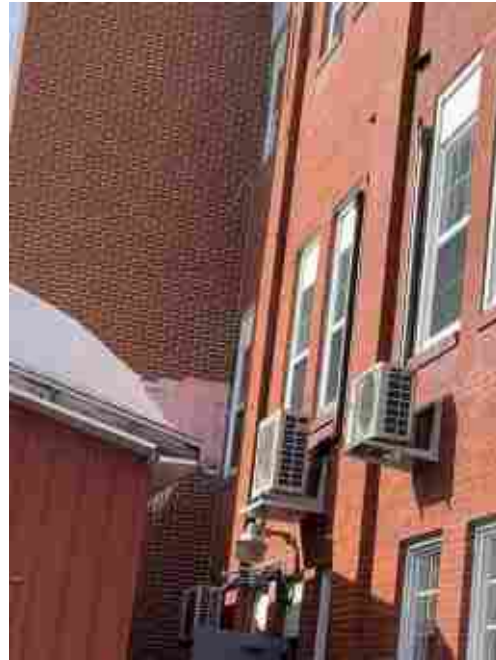
Photos of hose tower damage:

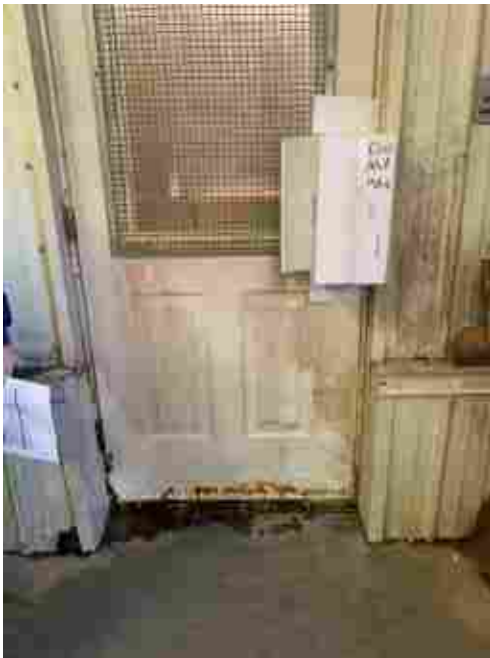
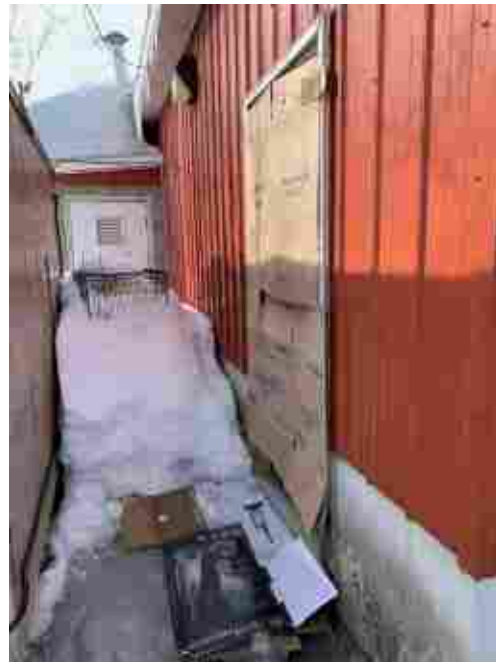
Photos of garage door that was not in-service during inspection but replaced 3/20/19:

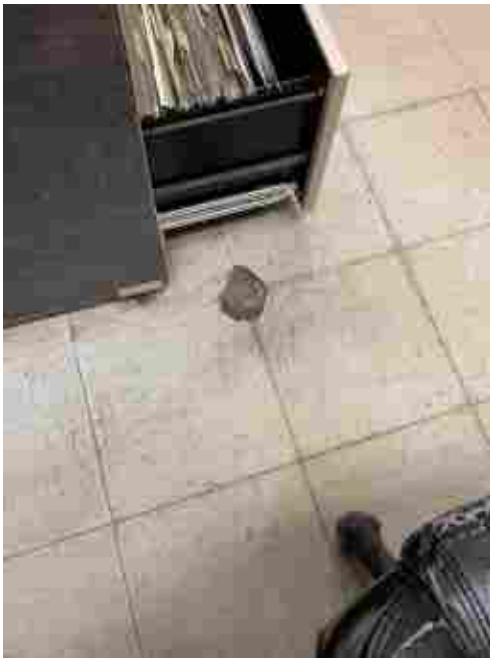
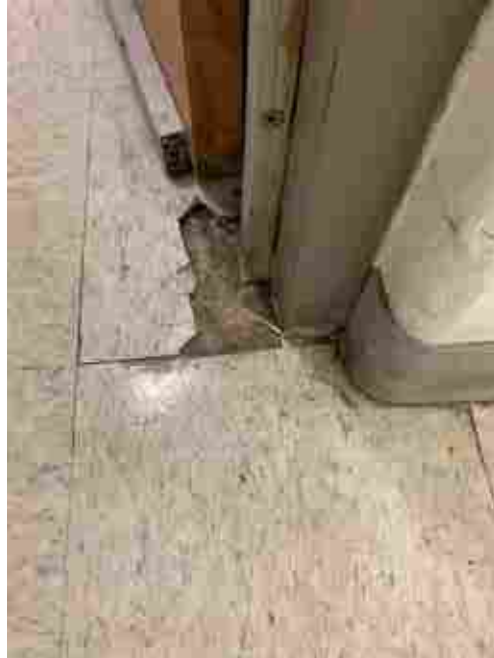
- Due to limited space, there is much to be improved in this area of the standard
  - 1910.22 (a)(1): "All places of employment, passageways, storerooms, service rooms, and walking-working surfaces kept in a clean, orderly, and sanitary condition."
  - 1910.21(b): definition "Walking-working surface means any horizontal or vertical surface on or through which an employee walks, works, or gains access to a work area or workplace location."
- Many areas where the floor is a trip hazard

Photos of walking-working surfaces in poor repair, broken tiles:

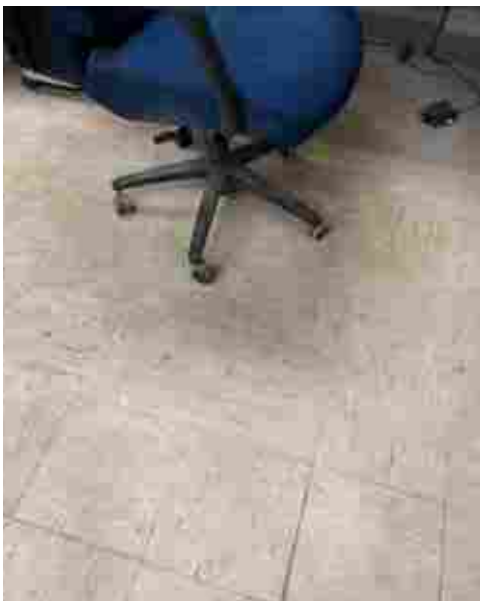
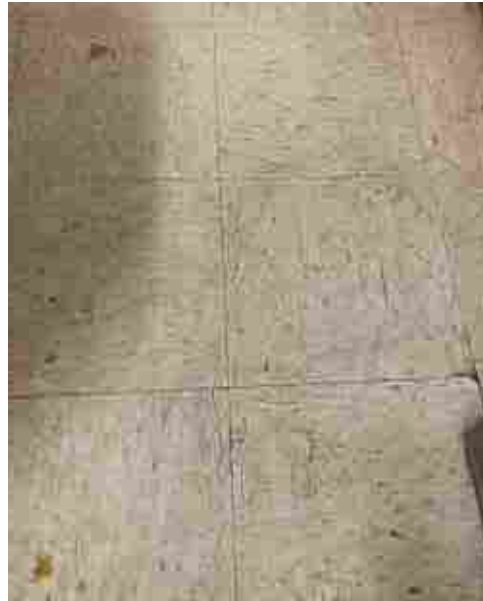
Photos of walking-working surfaces in poor repair, cracked tiles:

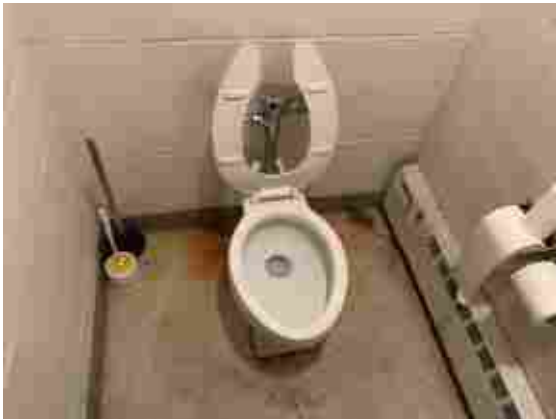
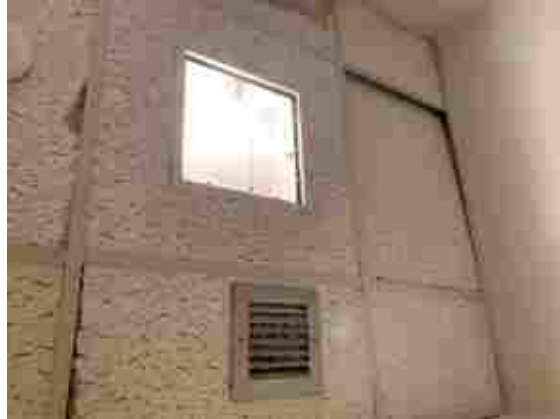
#### Photos of toilet facility for staff usage:

(furry vent and light with no cover)

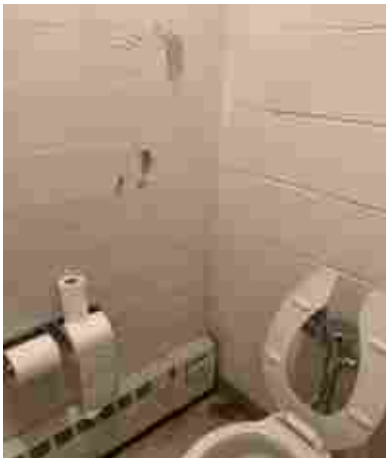
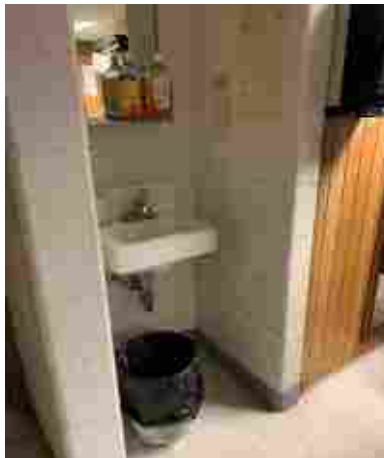
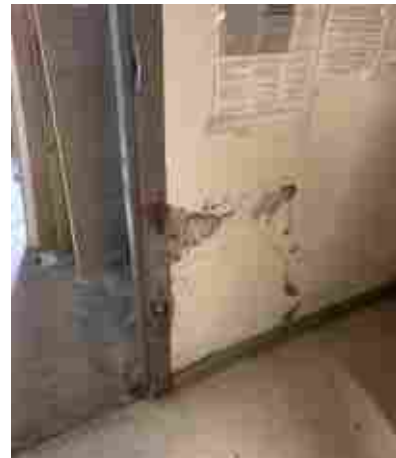
Toilet (walls damaged) – hand washing outside toilet and in the “break room” – damaged wall in “break room”

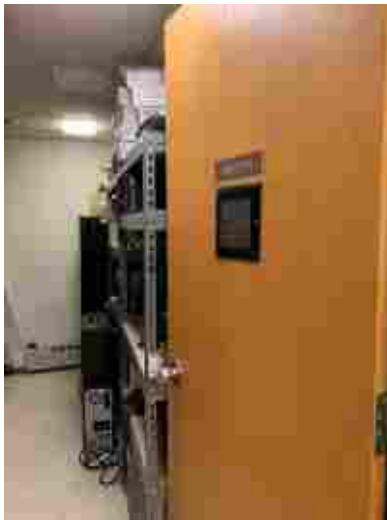
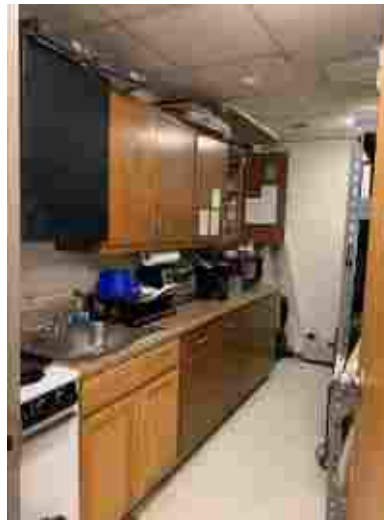
Photos of “kitchen” which also has department property storage:

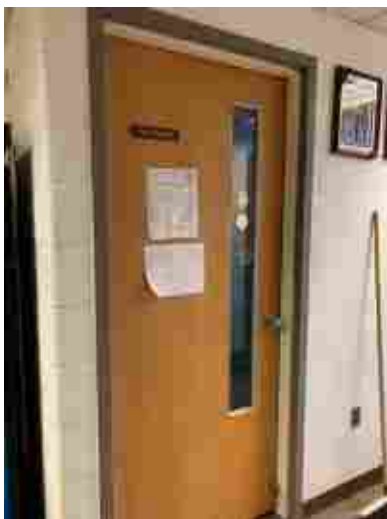
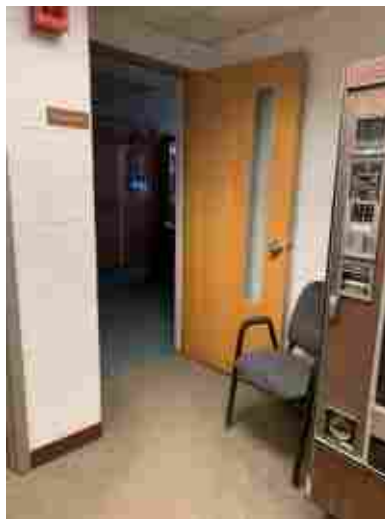
Private offices inside front door have no protection from active assailants. These doors are typically open.

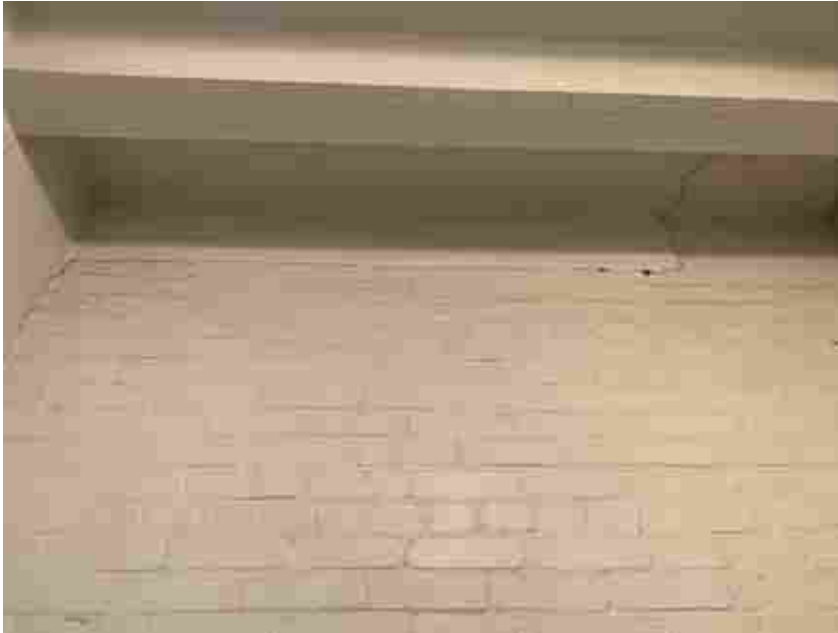
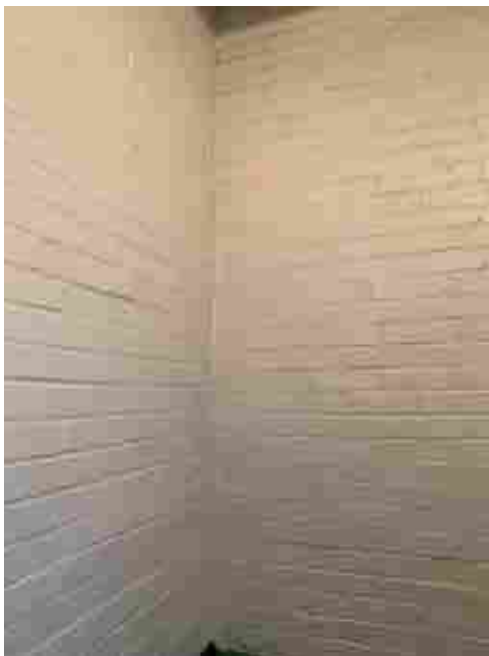
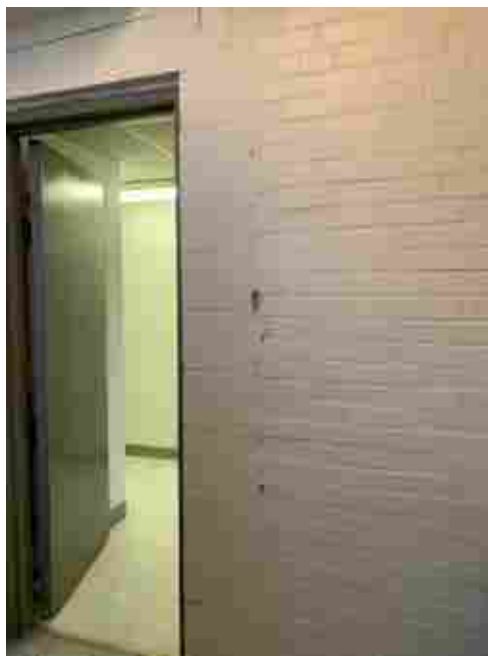
Building may have structural integrity issues which should be investigated by a qualified professional.

Cracks in west side cell area:

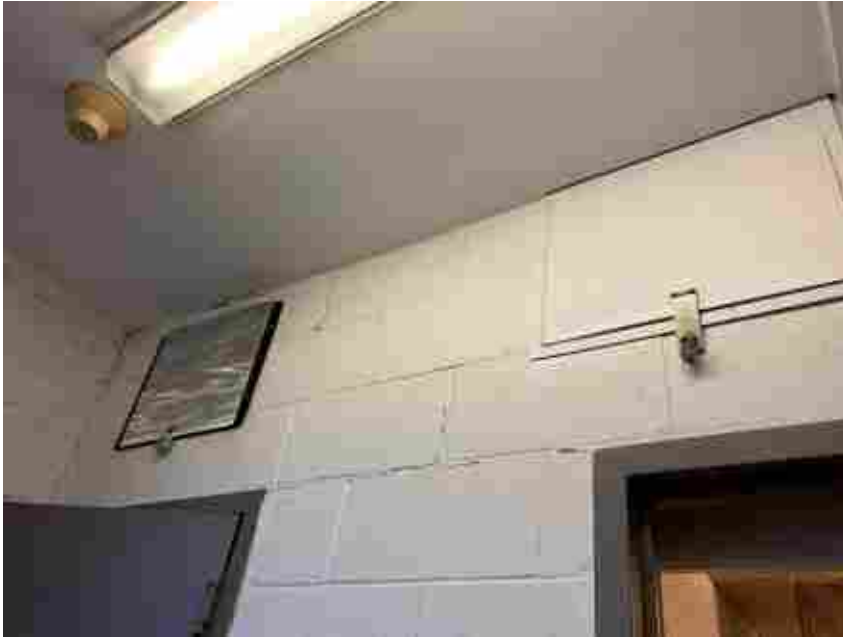
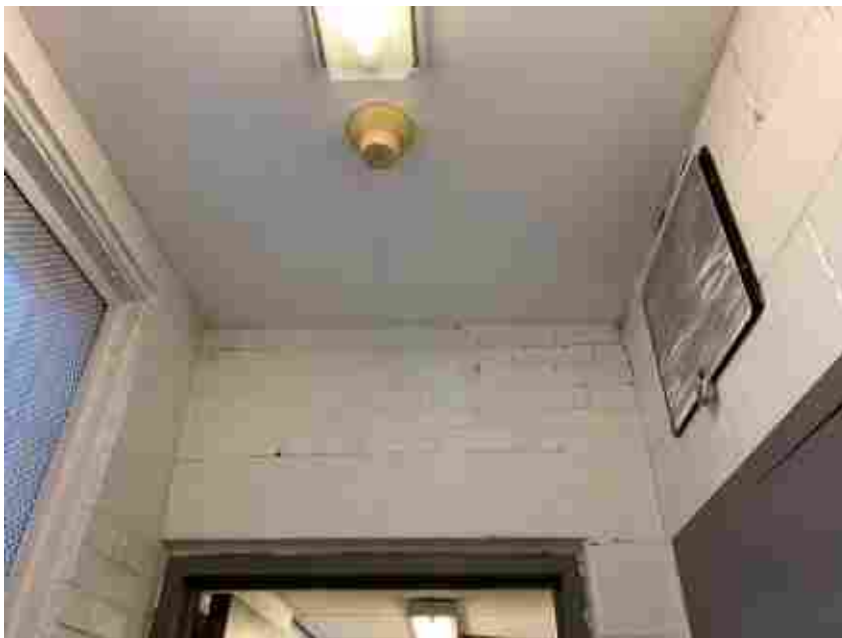
Building may have structural integrity issues which should be investigated by a qualified professional.

Cracks in duplex cell area:

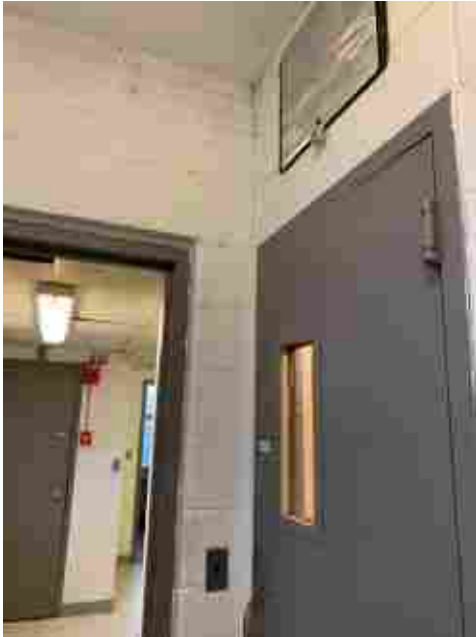
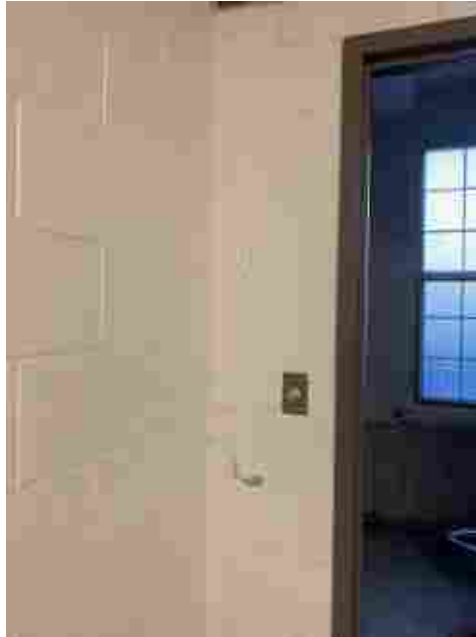
Building may have structural integrity issues which should be investigated by a qualified professional.

Cracks in duplex cell area:

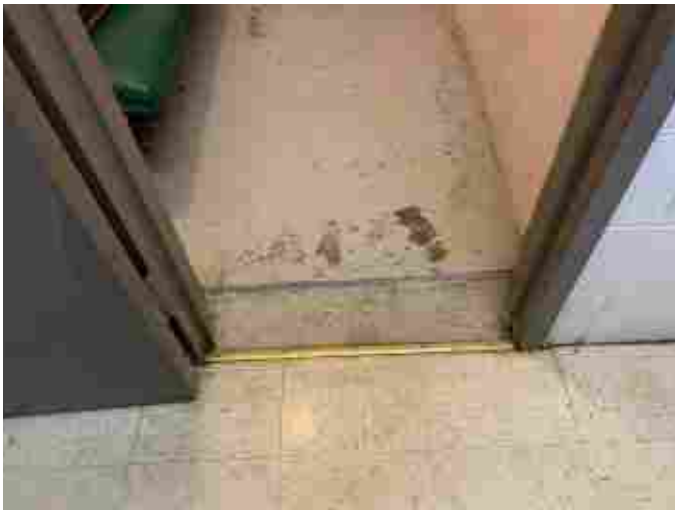
Trip hazard in the duplex cell area:

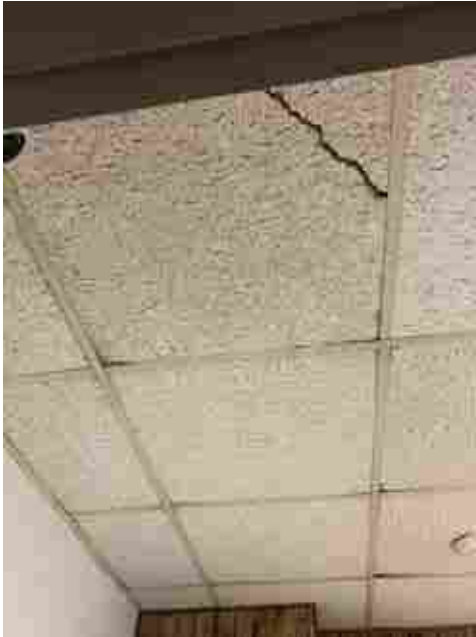
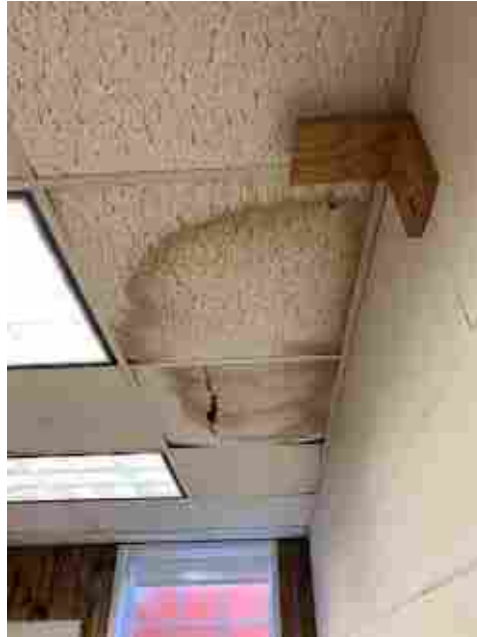
Photos of ceiling tiles in rear office area:

Evidence of moisture damage to ceiling tiles.

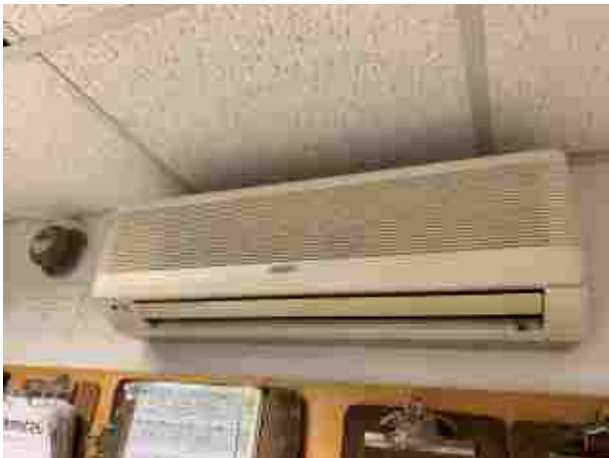
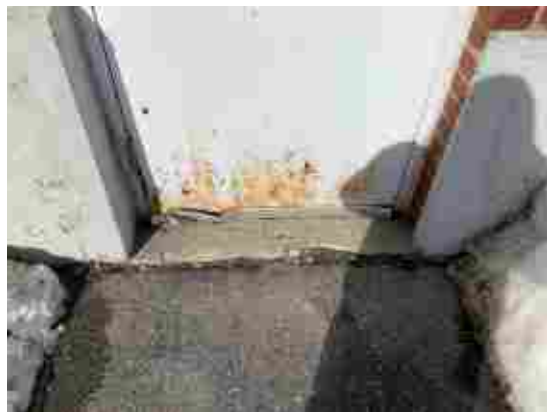
Heat not regulated with temperature controls. Door is opened when hot. Heat pump not working (bottom left):

Right side photo (above) is of exterior access door on 25 High Street. Door is used to bring volatile prisoners into the building instead of the front door. Entry / Exit by key only (not a primary entrance / exit door or fire door)

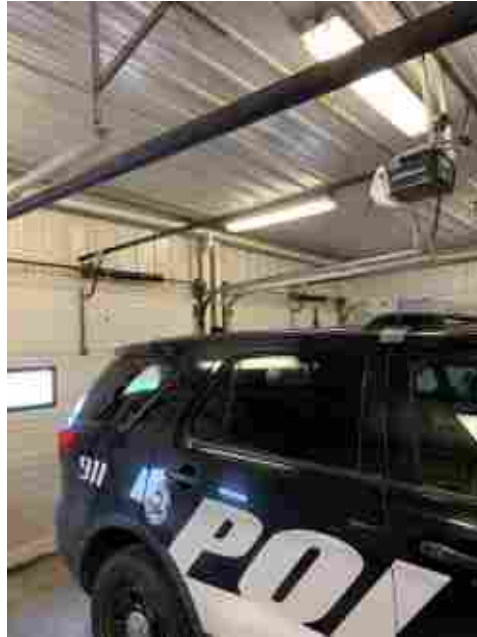
Overhead doors not tall enough:

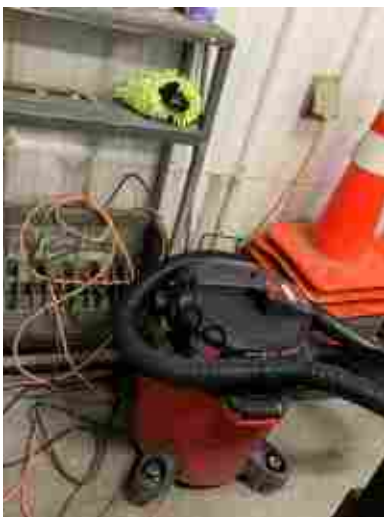
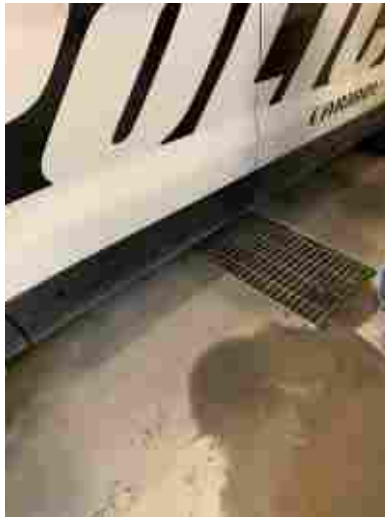
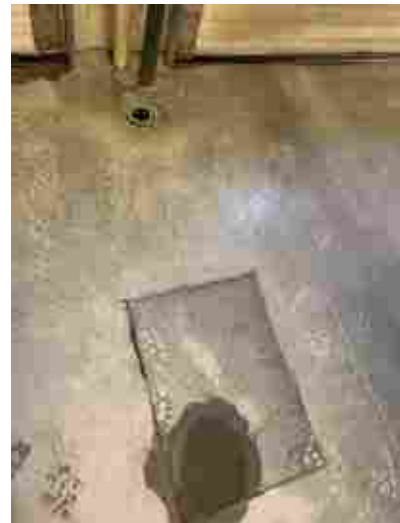
Shop vac needed due to inadequate floor drains:

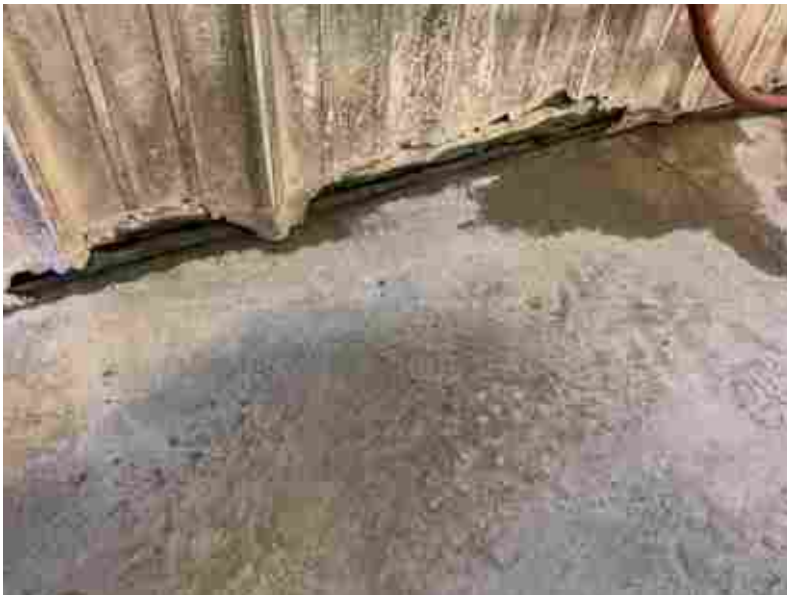
Possible issues with southern wall:
