Caribou Police Department

Assessment

In January of 2020, the City of Caribou, Maine contracted with Artifex Architects and Engineers and with Public Safety Consulting Architect, Manns Woodward Studios (MWS) to perform a comprehensive assessment for the Caribou Police department. The scope of work addressed three primary areas of focus:

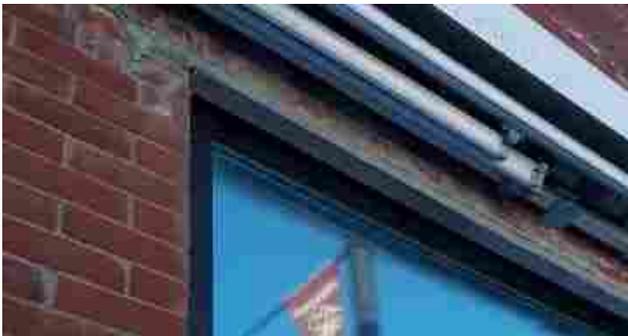
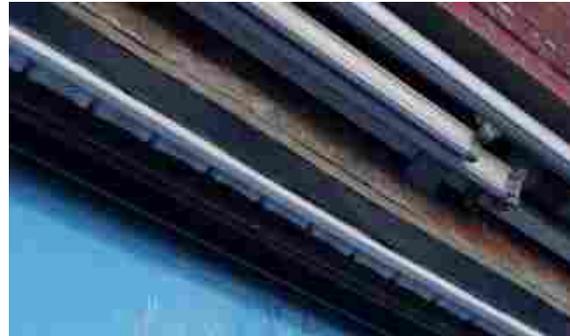
The front windows are commercial storefront with double-glazed glass. The aluminum is in generally good condition, but the masonry surrounding is in poor condition and small ad hoc details have been made to maintain a generally acceptable appearance.

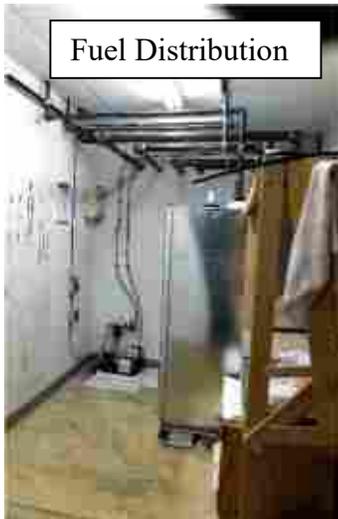
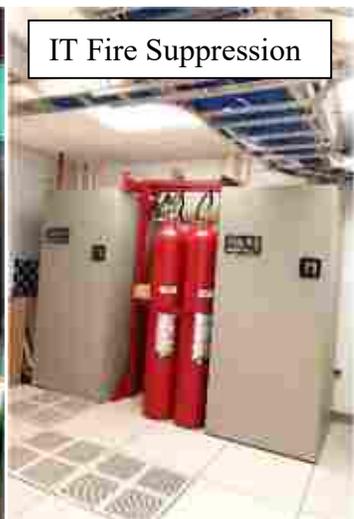
The mechanical system for the building is a ducted forced air system which provides for both heating and air conditioning. The mechanical condensing units were on the roof with air handlers in a penthouse structure accessed by stairs from the second floor mechanical room which contained the building boilers. The oddest element of this system was the fuel storage and delivery: fuel was stored in a partially buried tank at the east side of the building on what appears to be the neighbor's property. It is located below a major exit from the building (one of three entries/exits and the only accessible entrance to the second floor). Diesel fuel, for the emergency generator, was also stored on site with a mini-storage area at the first floor of the building and pumps within the building, piping the fuel to the generator at the first floor rear of the building. The condition of this was hard to assess and the code compliance was also questionable.

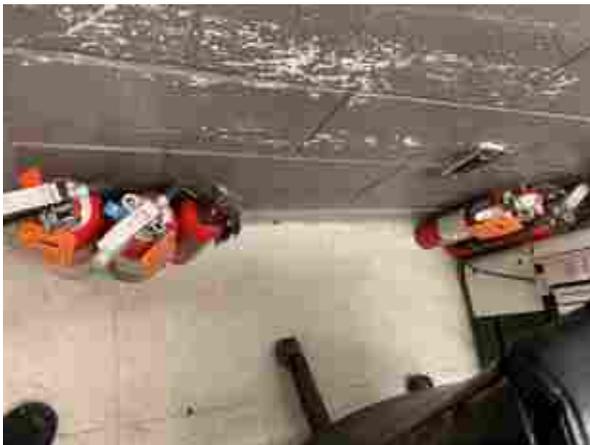
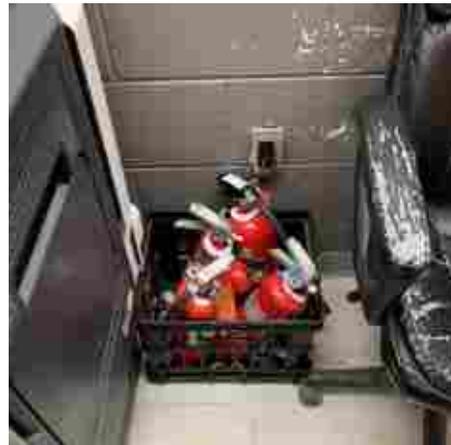
Photos: (Before)

- Due to lack of communication within committee, this had not been done
 - Update: Issue resolved – now compliant
- Chief Susi said that the fire extinguishers designated as vehicle backups should be in a crate to avoid damage
 - Update: Issue resolved – now compliant

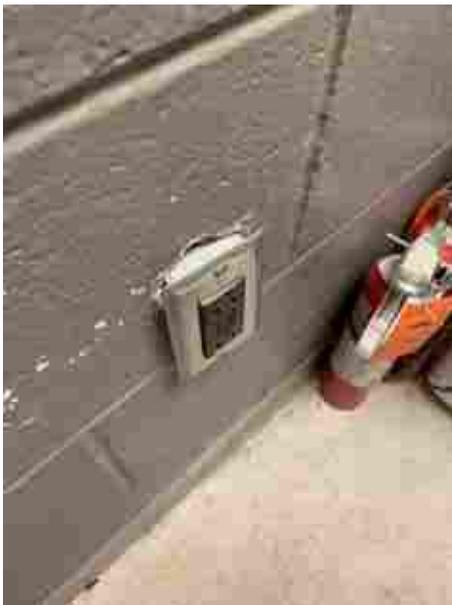
Photo:

- Compliant: no deficient equipment noticed during visit (not many in view due to amount of property)
- One in dispatch area is loose in wall

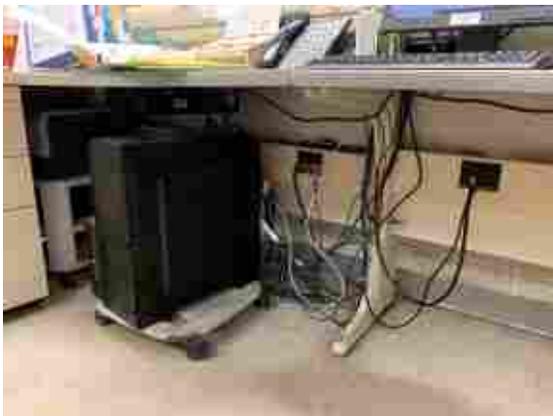
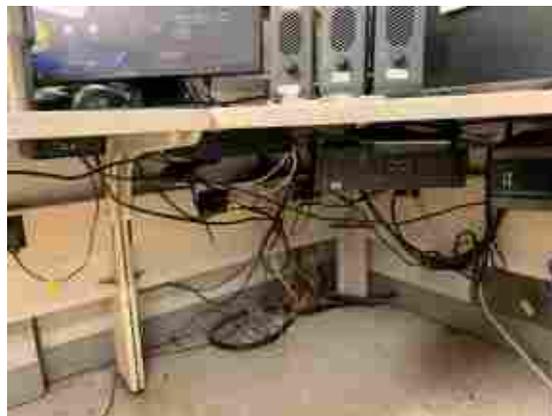
Photos of under desk wiring in dispatch:

Wiring supported and protected from damage

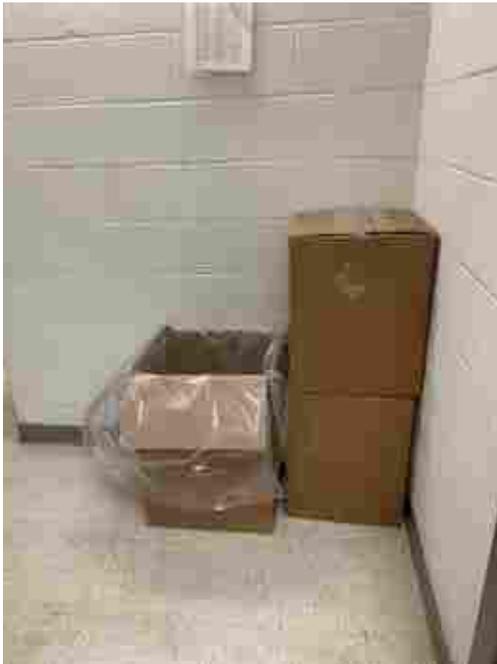
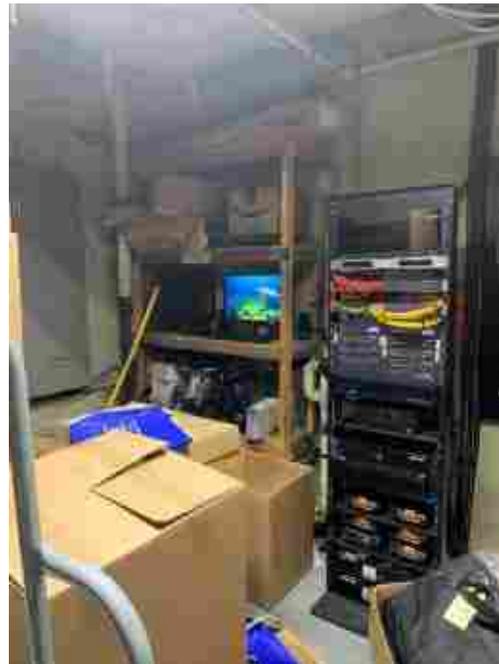
Photos of storage areas:

- Furnace / boiler room not viewed during visit
- All rooms are used for storage due to lack of proper space for operation of police department.
- Private offices were not photographed due to the confidential nature of the business conducted in the police department. Those areas too are used for storage. In some rooms, boxes and other items must be moved to access file storage.

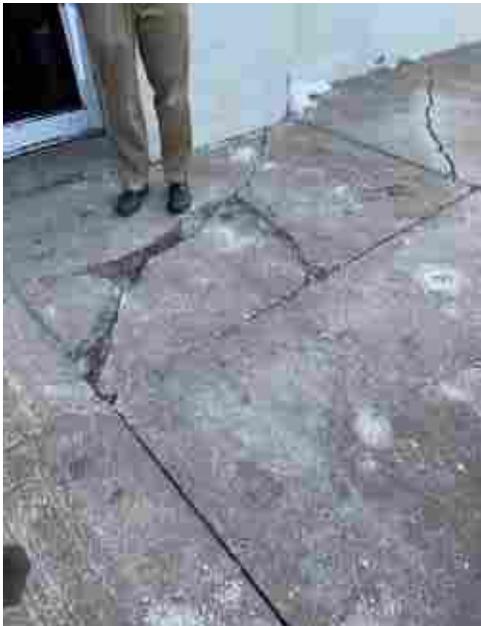
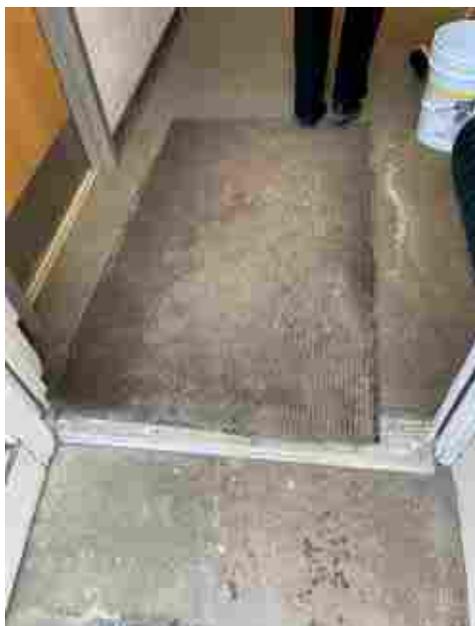
Photos of front discharge area:

- Safety hazards exist when exiting each door
 - Front Door – uneven surface on sidewalk, rug not regularly replaced (trip hazards)
 - Rear door – rugs not regularly replaced, ill fitting; brick material regularly falls from building and hose tower with potential to hit employees
 - Update: On 3/20/2019, fuel delivery person reported a “near miss” with a falling brick
- Door in detached garage not usable during inspection
 - Update: Replaced 3/20/2019

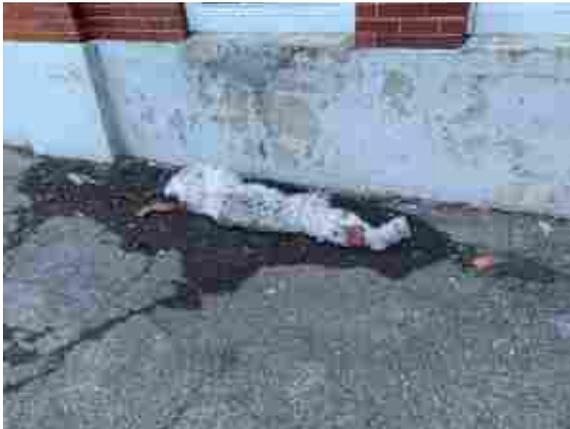
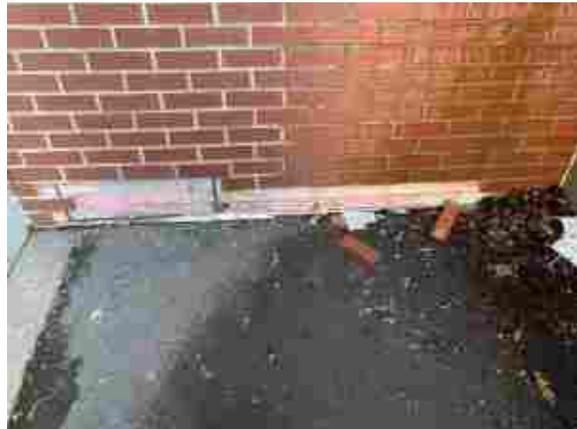
Debris falling from building and hose tower:

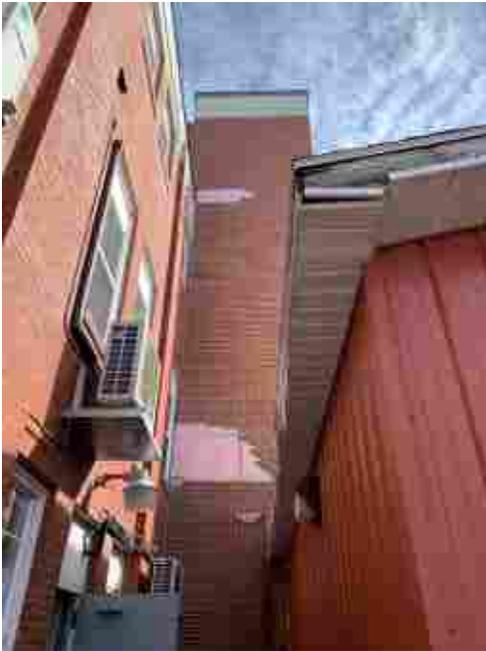
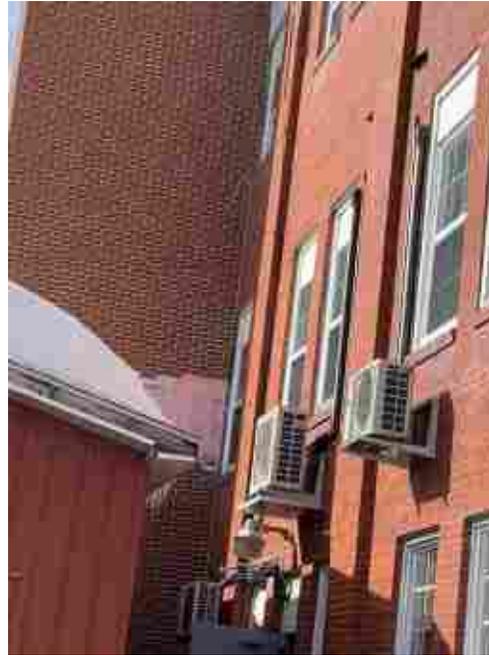
Photos of hose tower damage:

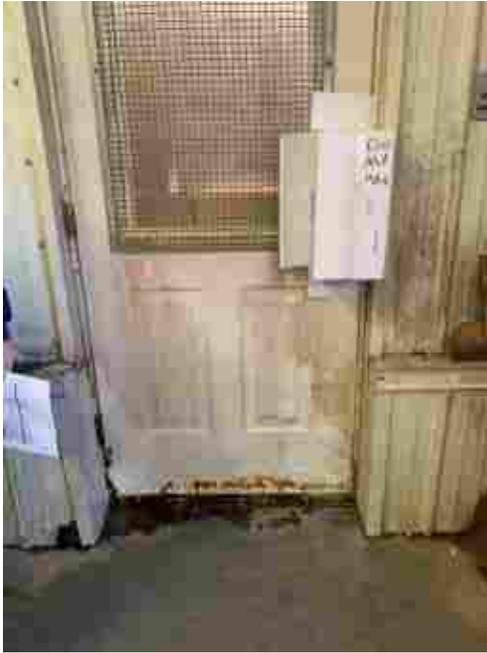
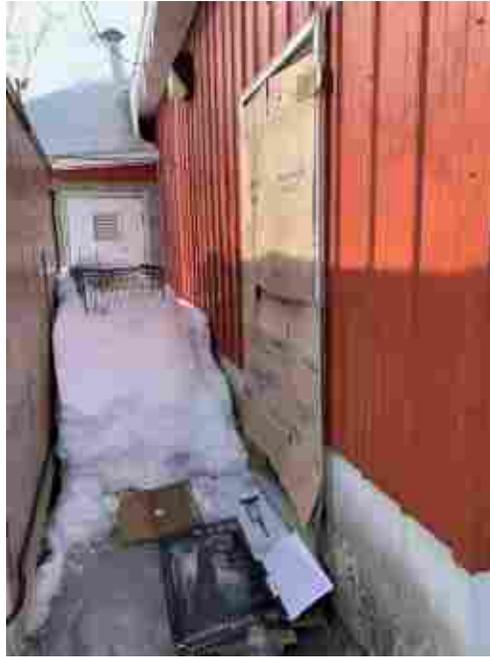
Photos of garage door that was not in-service during inspection but replaced 3/20/19:

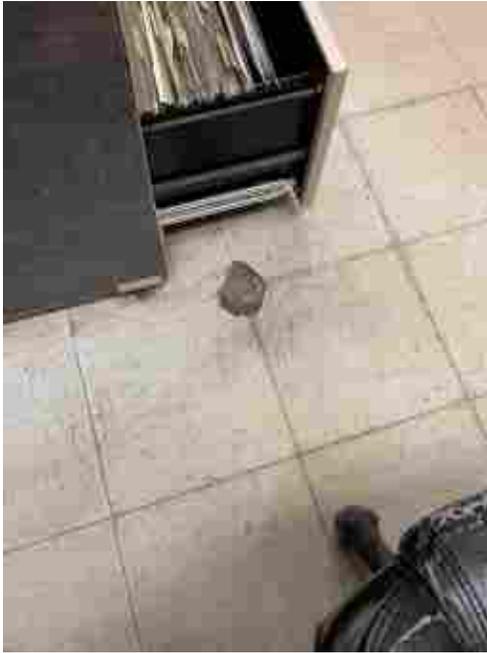
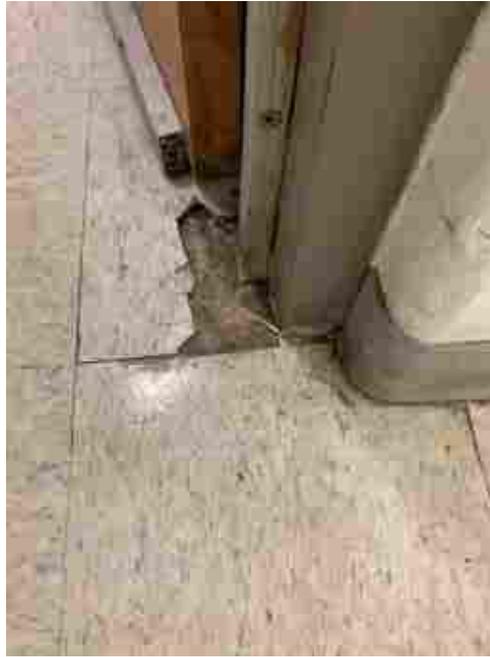
- Due to limited space, there is much to be improved in this area of the standard
 - 1910.22 (a)(1): "All places of employment, passageways, storerooms, service rooms, and walking-working surfaces kept in a clean, orderly, and sanitary condition."
 - 1910.21(b): definition "Walking-working surface means any horizontal or vertical surface on or through which an employee walks, works, or gains access to a work area or workplace location."
- Many areas where the floor is a trip hazard

Photos of walking-working surfaces in poor repair, broken tiles:

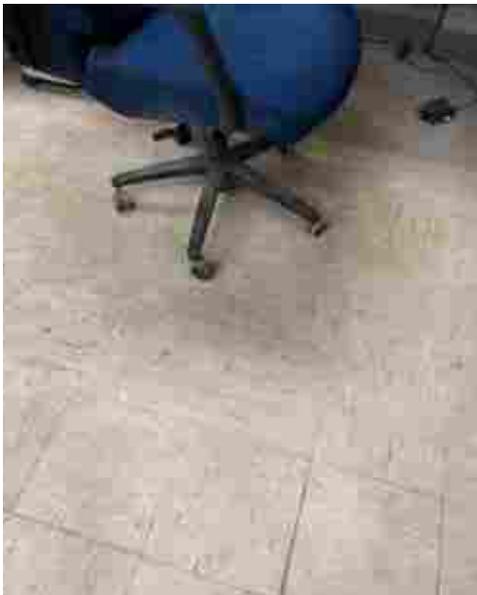
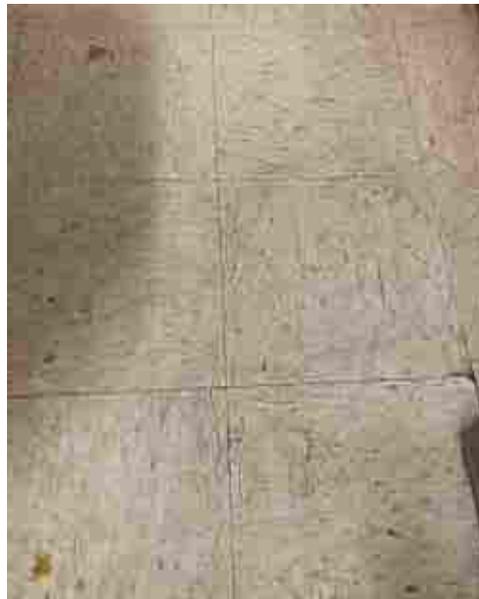
Photos of walking-working surfaces in poor repair, cracked tiles:

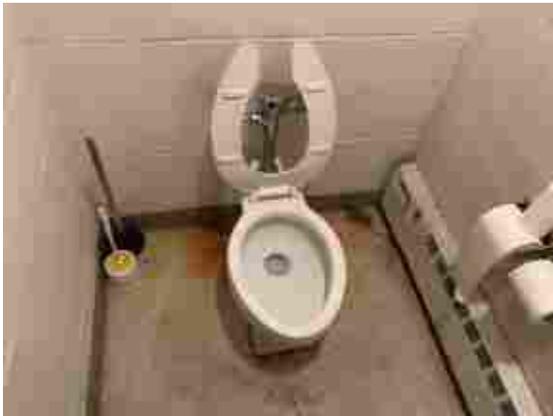
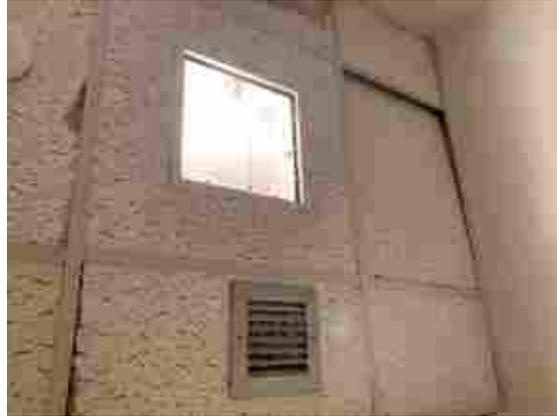
Photos of toilet facility for staff usage:

- “All places of employment shall be kept clean to the extent that the nature of the work allows” 1910.141(a)(3)
- “Washing facilities shall be maintained in a sanitary condition” 1910.141(d)(1)
- “Change rooms. Whenever employees are required by a particular standard to wear protective clothing because of the possibility of contamination with toxic materials, change rooms equipped with storage facilities for street clothes and separate storage facilities for the protective clothing shall be provided.” 1910.141(e)
 - No private changing area
- “Eating and drinking areas. No employee shall be allowed to consume food or beverages in a toilet room nor in any area exposed to a toxic material.” 1910.141(g)(2)

(furry vent and light with no cover)

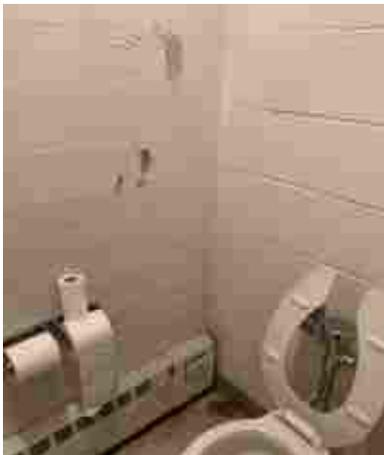
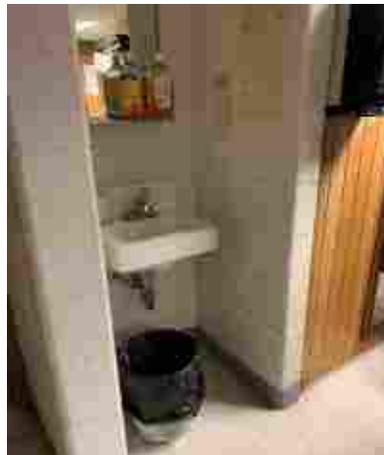
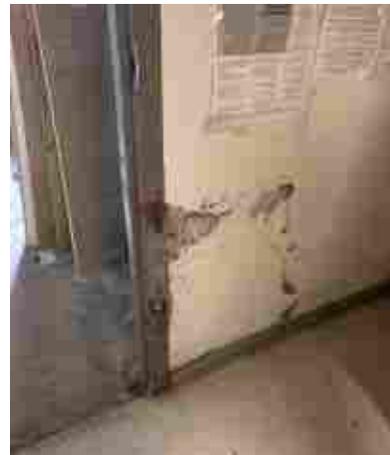
Toilet (walls damaged) – hand washing outside toilet and in the “break room” – damaged wall in “break room”

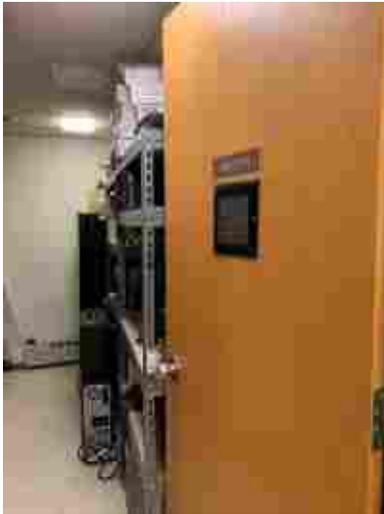
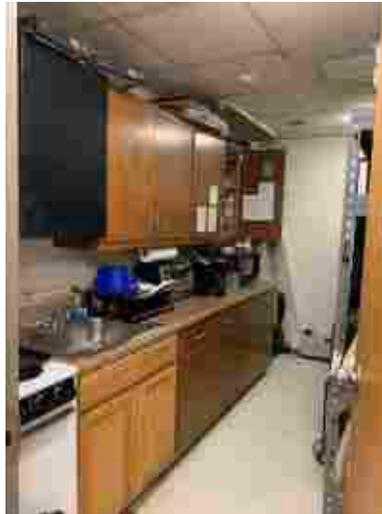
- “The employer shall establish and maintain good housekeeping practices to eliminate hazards to employees to the extent practicable.” 1915.81 (a)(1)
- “The employer shall store materials in a manner that does not create a hazard for employees.” 1915.81 (a)(3)
 - There are many photos of storage areas that are overloaded on previous pages.

Photos of “kitchen” which also has department property storage:

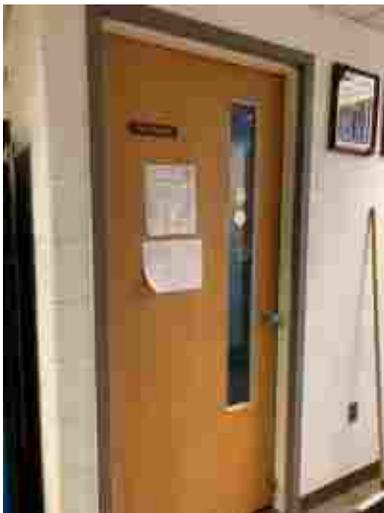
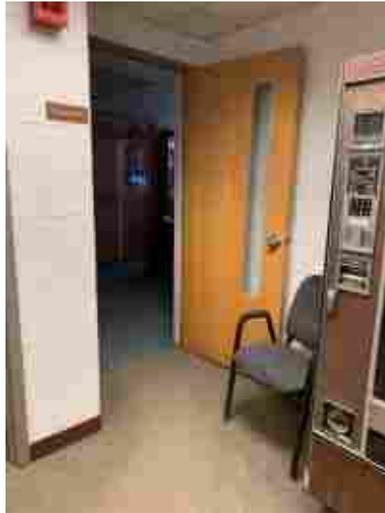
Private offices inside front door have no protection from active assailants. These doors are typically open.

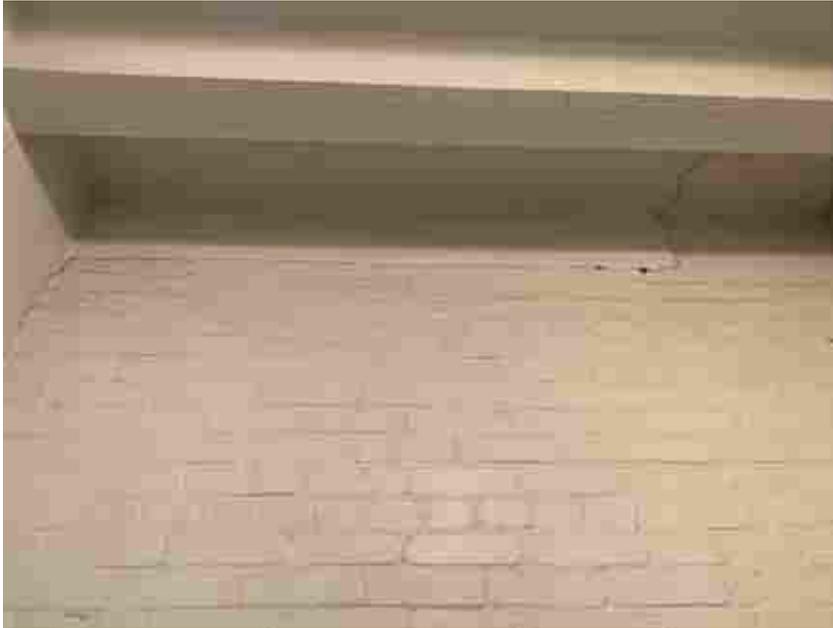
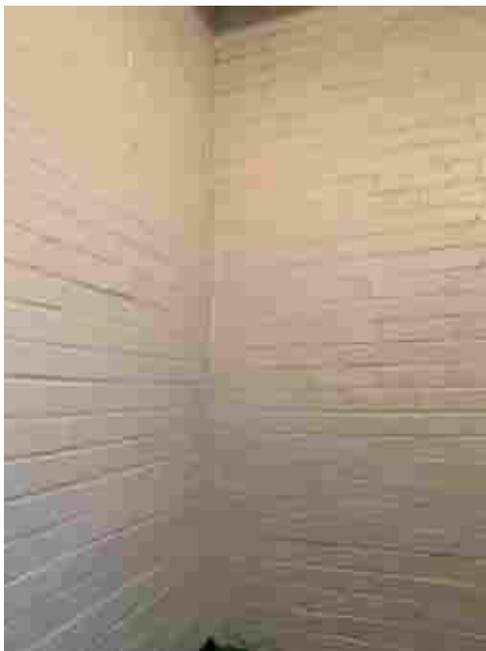
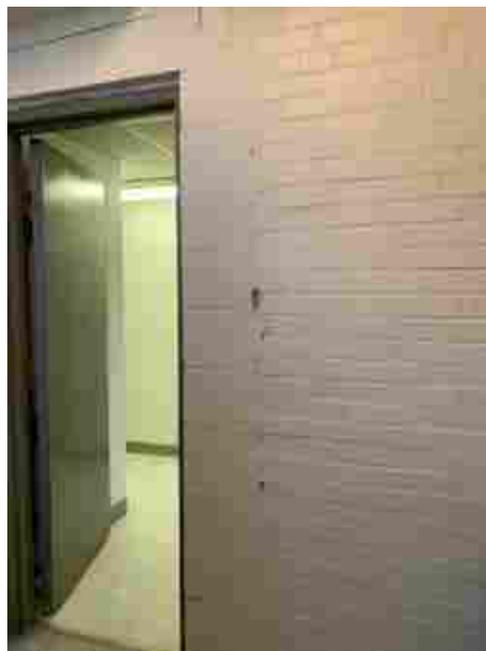
Building may have structural integrity issues which should be investigated by a qualified professional.

Cracks in west side cell area:

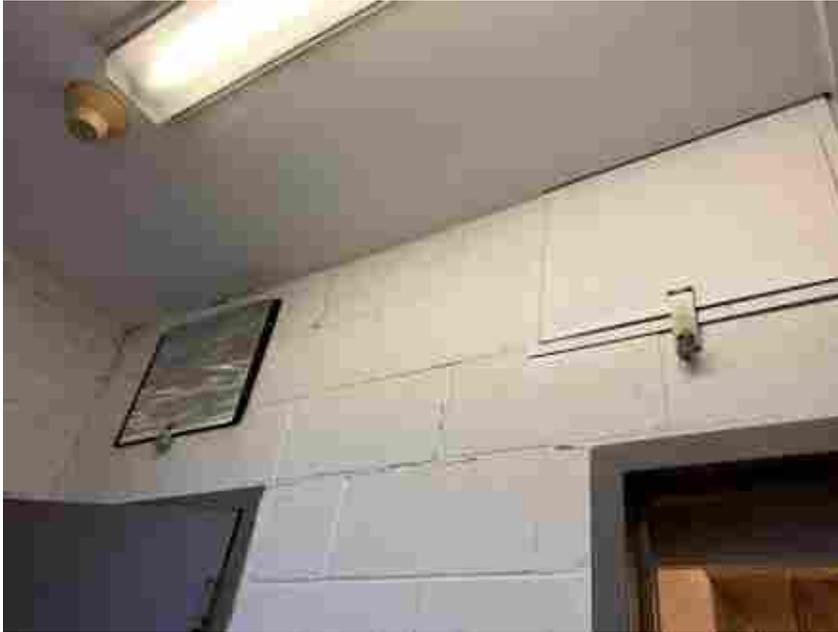
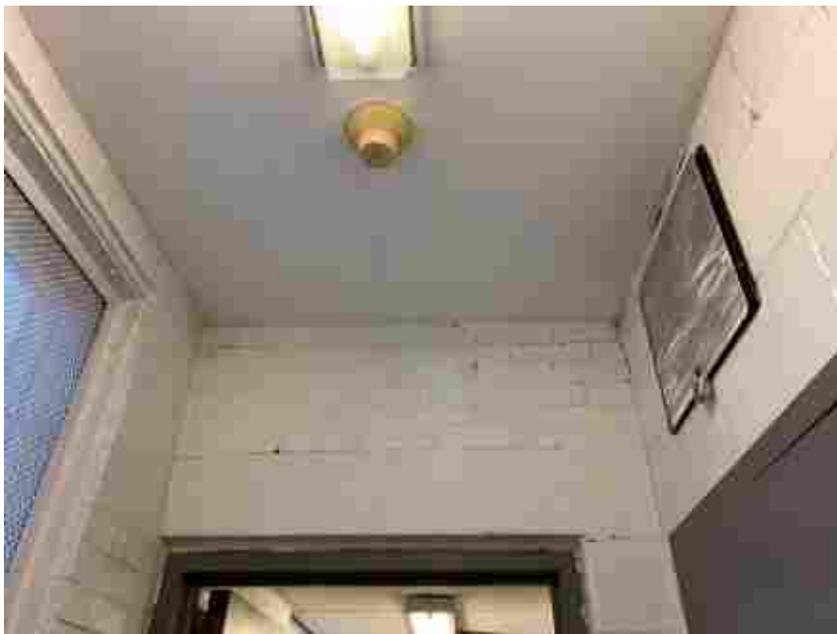
Building may have structural integrity issues which should be investigated by a qualified professional.

Cracks in duplex cell area:

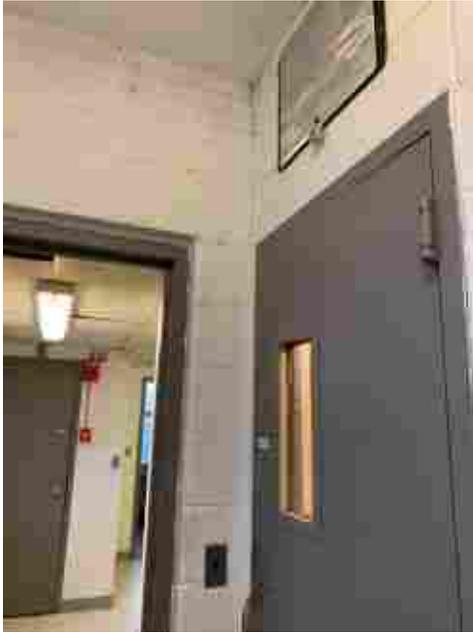
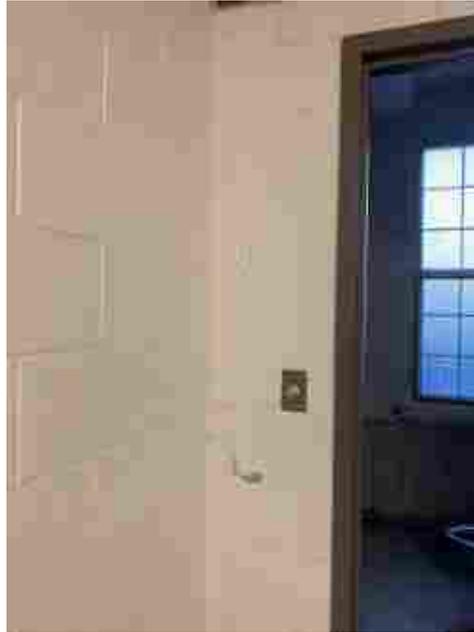
Building may have structural integrity issues which should be investigated by a qualified professional.

Cracks in duplex cell area:

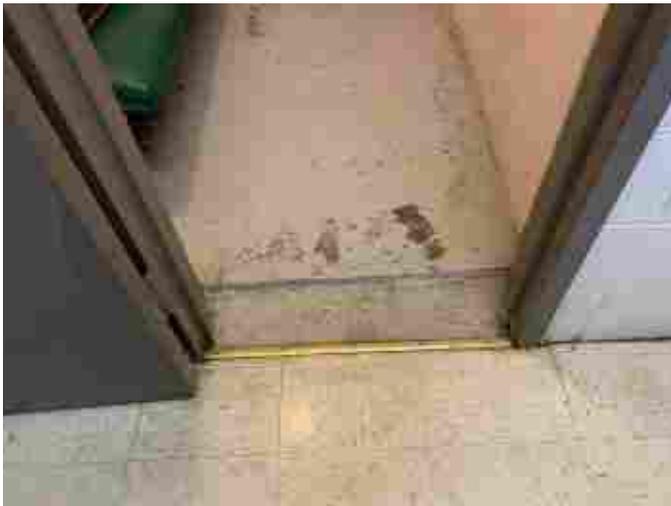
Trip hazard in the duplex cell area:

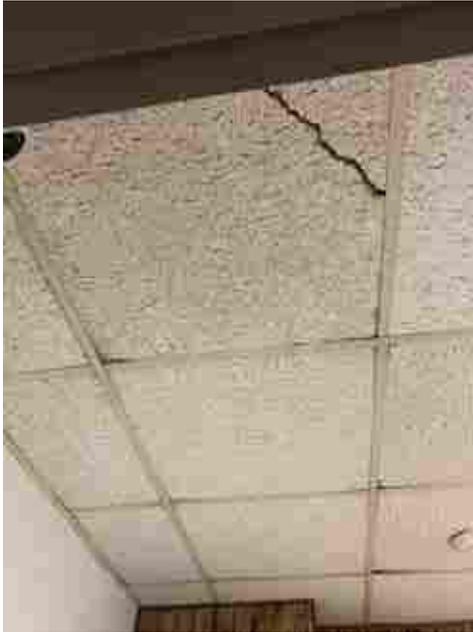
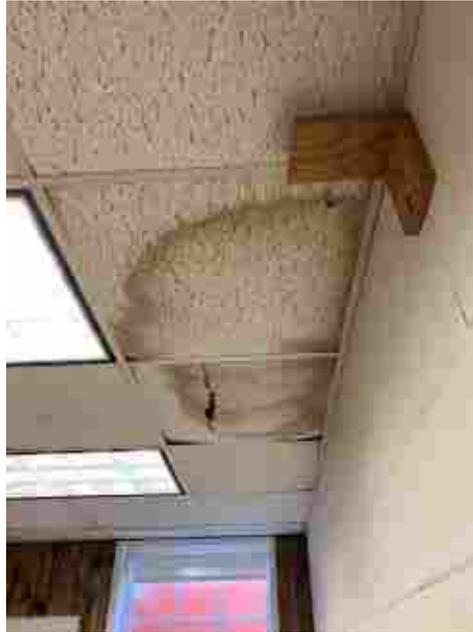
Photos of ceiling tiles in rear office area:

Evidence of moisture damage to ceiling tiles.

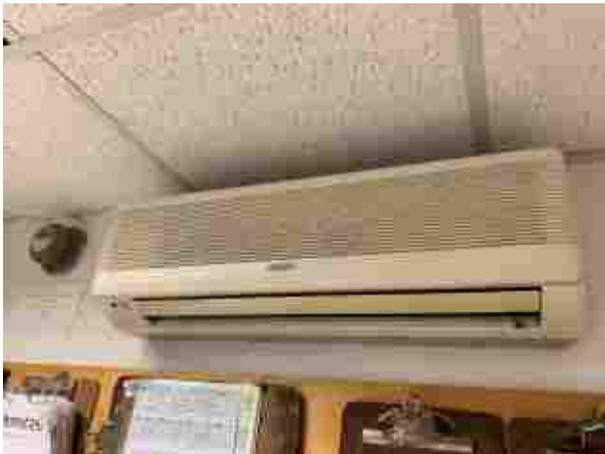
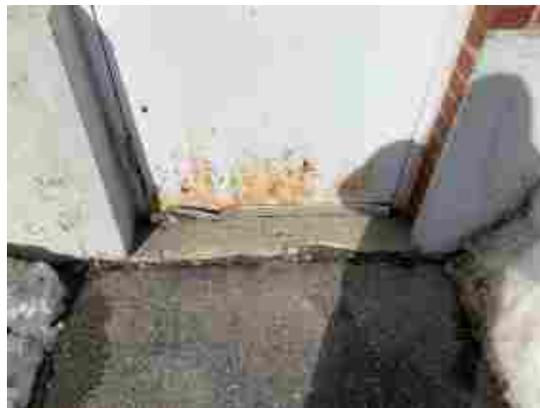
Heat not regulated with temperature controls. Door is opened when hot. Heat pump not working (bottom left):

Right side photo (above) is of exterior access door on 25 High Street. Door is used to bring volatile prisoners into the building instead of the front door. Entry / Exit by key only (not a primary entrance / exit door or fire door)

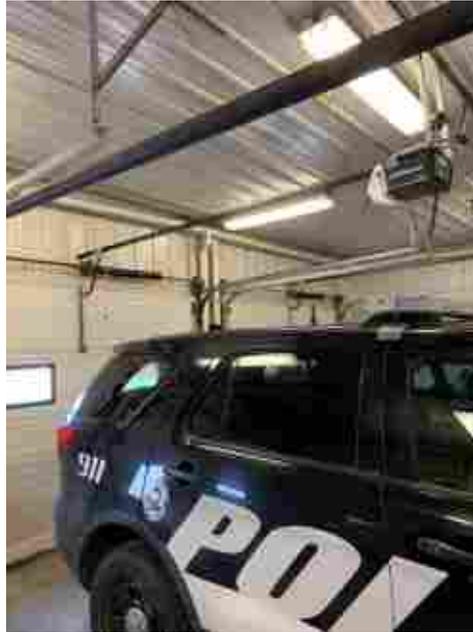
Overhead doors not tall enough:

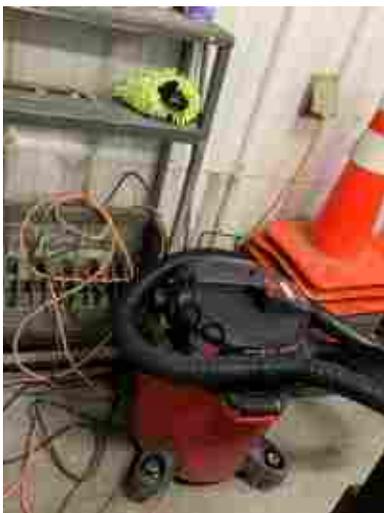
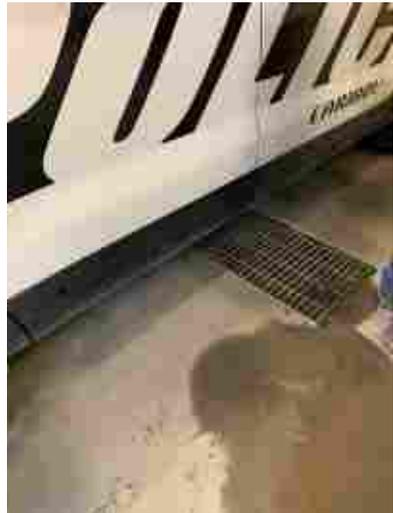
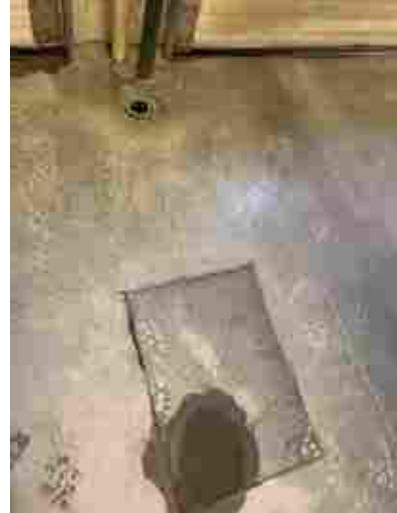
Shop vac needed due to inadequate floor drains:

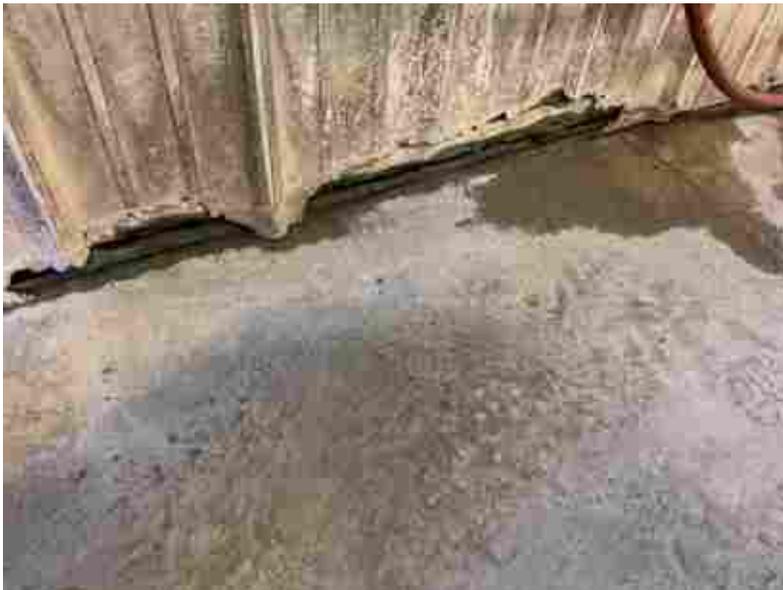
Possible issues with southern wall:
