## County Environmental Engineering, Inc.

Re: Draft Analysis of Brownfields Cleanup Alternatives  
Caribou Diesel Electric Power Plant and Associated Outbuildings  
142 Lower Lyndon Street, Caribou, Maine

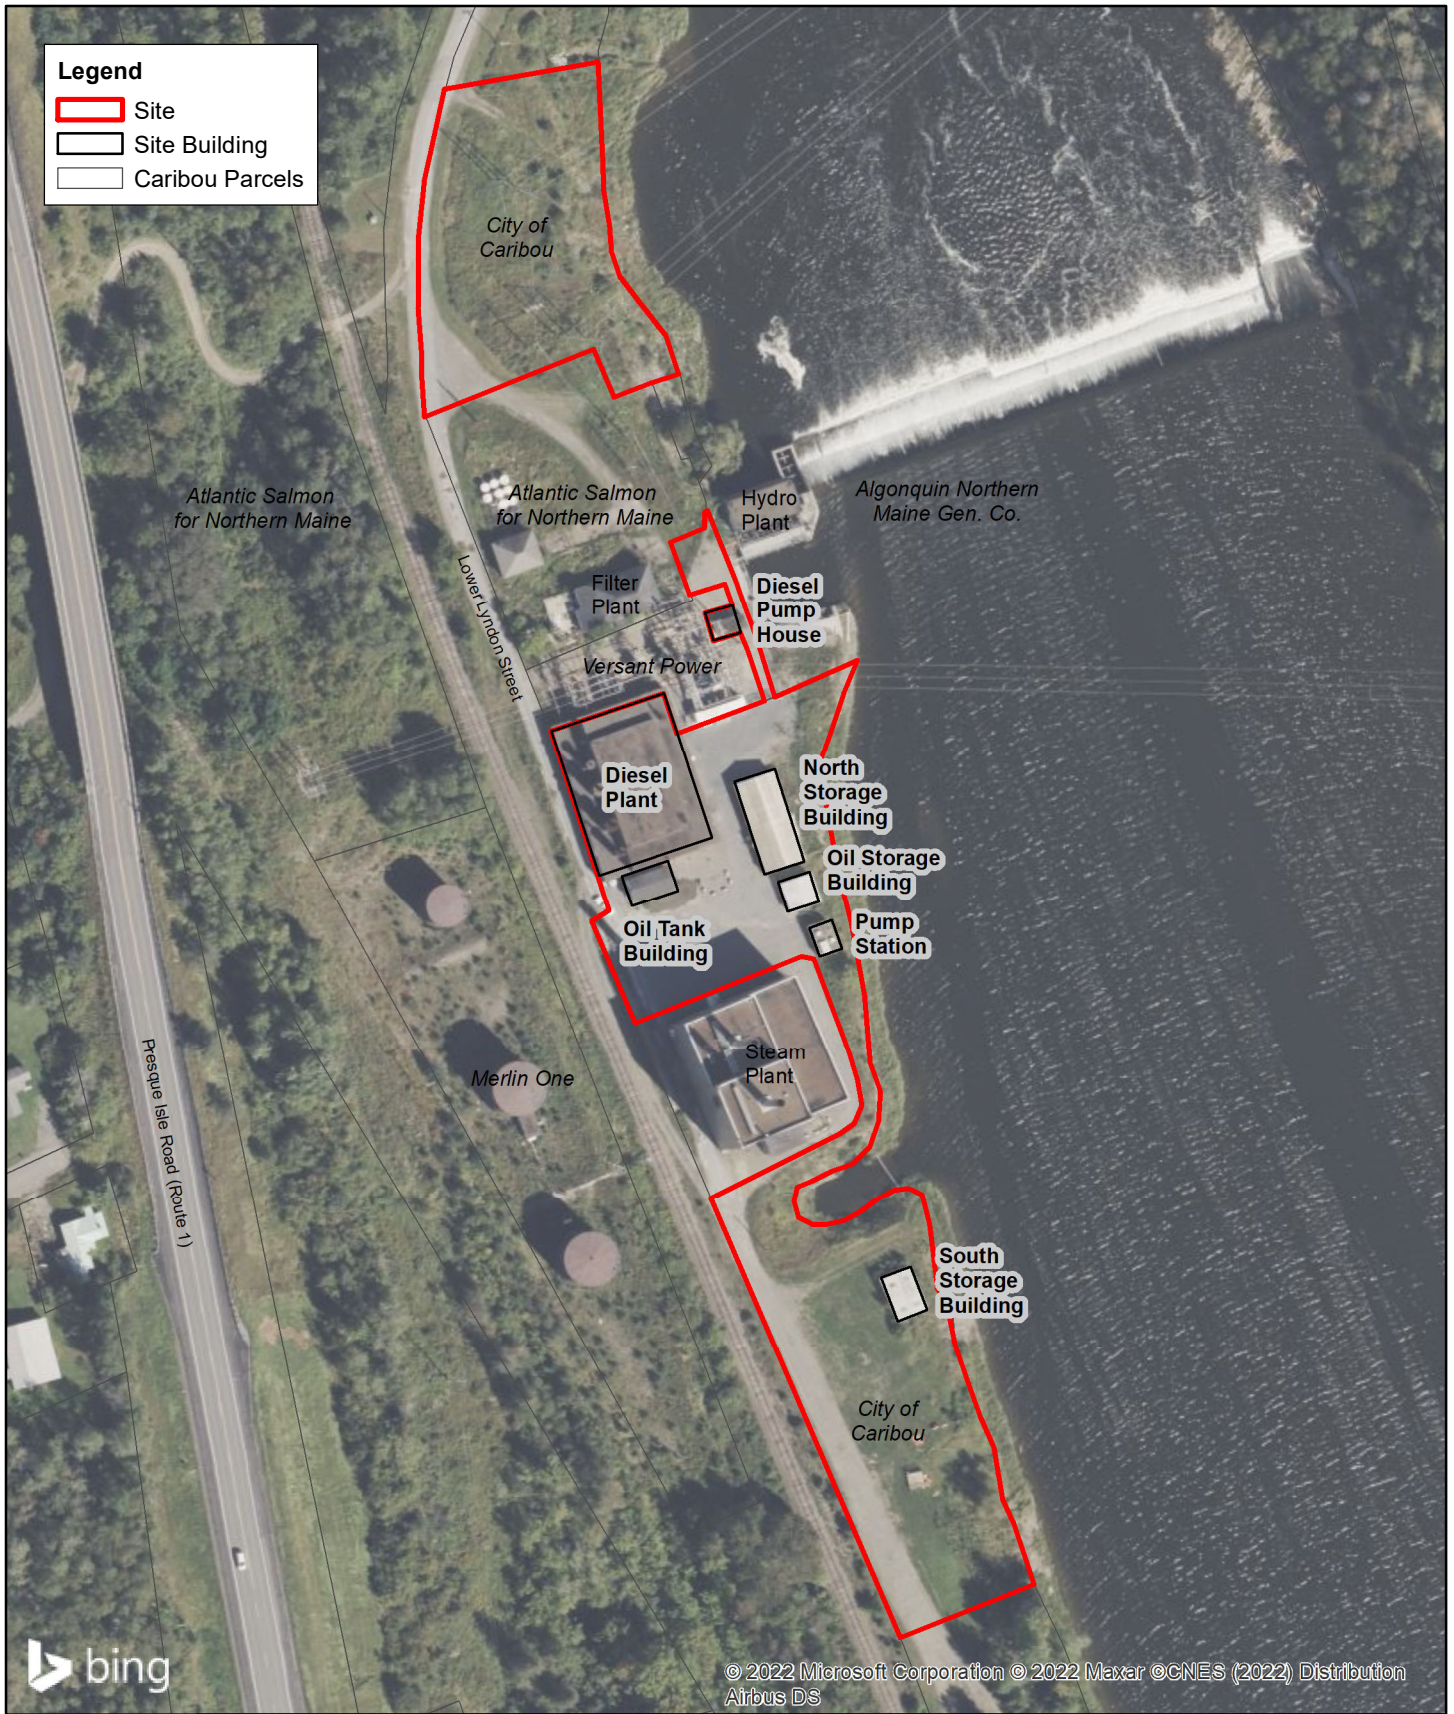
Analysis of Brownfields Cleanup Alternatives  
 Diesel Electric Power Plant and Associated Outbuildings  
 142 Lower Lyndon Street, Caribou  
 Aroostook County, Maine

As shown on the attached Location Map (Figure 1), the Site is located on the west side of the Aroostook River near the historic Caribou dam (circa 1889). As shown on the attached Site Map (Figure 2), the Site (3.2 acres) is developed with a 12,200-square foot diesel plant, diesel pump house, oil tank building, north storage building, oil storage building, pump station, and south storage building. The total building footprint at the Site is approximately 17,300 square feet. The surrounding area consists of an abandoned steam electric power plant, abandoned bulk plant, active electrical switch station, inactive hydroelectric plant, and former municipal water filter plant.
