TABLE OF CONTENTS

A) Need for a Facility

City of Caribou
Caribou Police Department
Project No. 2023102

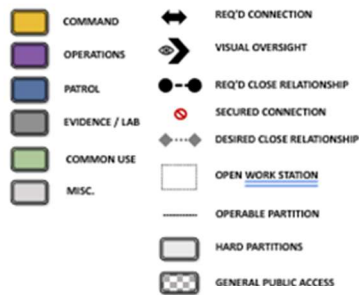
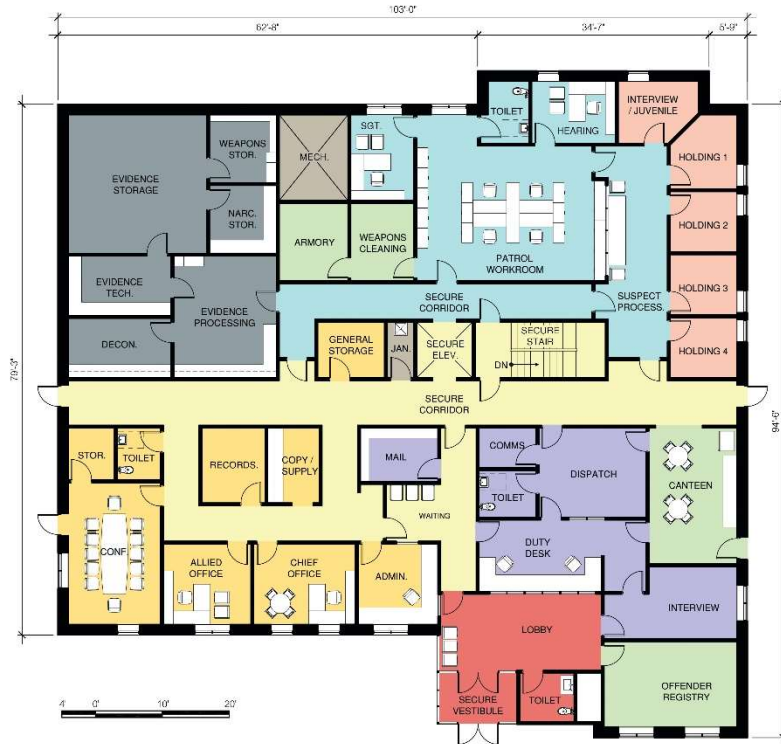
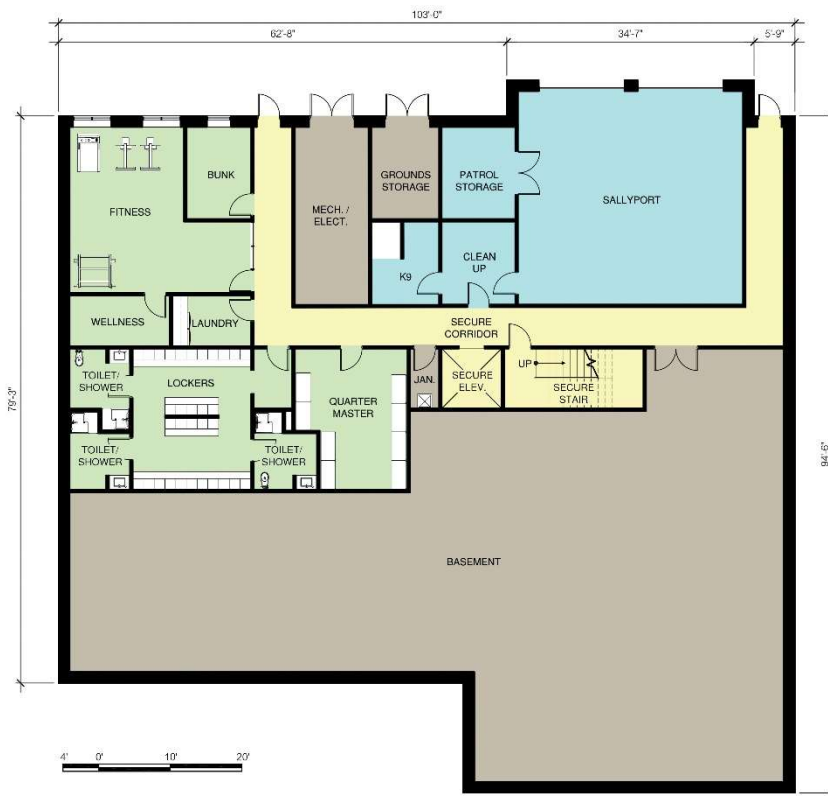
Bubble Diagram of Program relationships

GROUP		AREA	
A	COMMON USE	2,452	GSF
B	OPERATIONS	2,341	GSF
C	ADMINISTRATION	1,602	GSF
D	PATROL	2,349	GSF
E	EVIDENCE	1,177	GSF
F	OUTBUILDING / SUPPORT	1,968	GSF
TOTAL BUILDING AREA		11,890	GSF
CONDITIONED SPACE		9,922	GSF
UNCONDITIONED SPACE		1,968	GSF
TOTAL		11,890	GSF

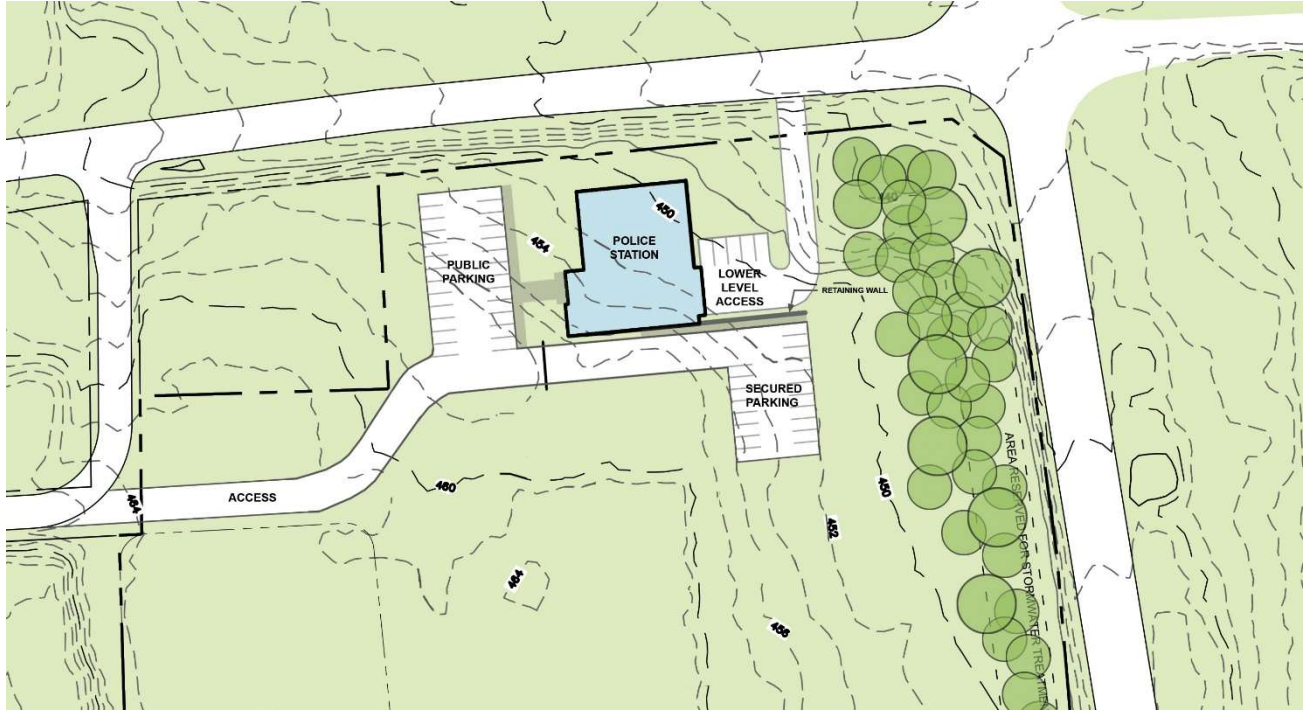
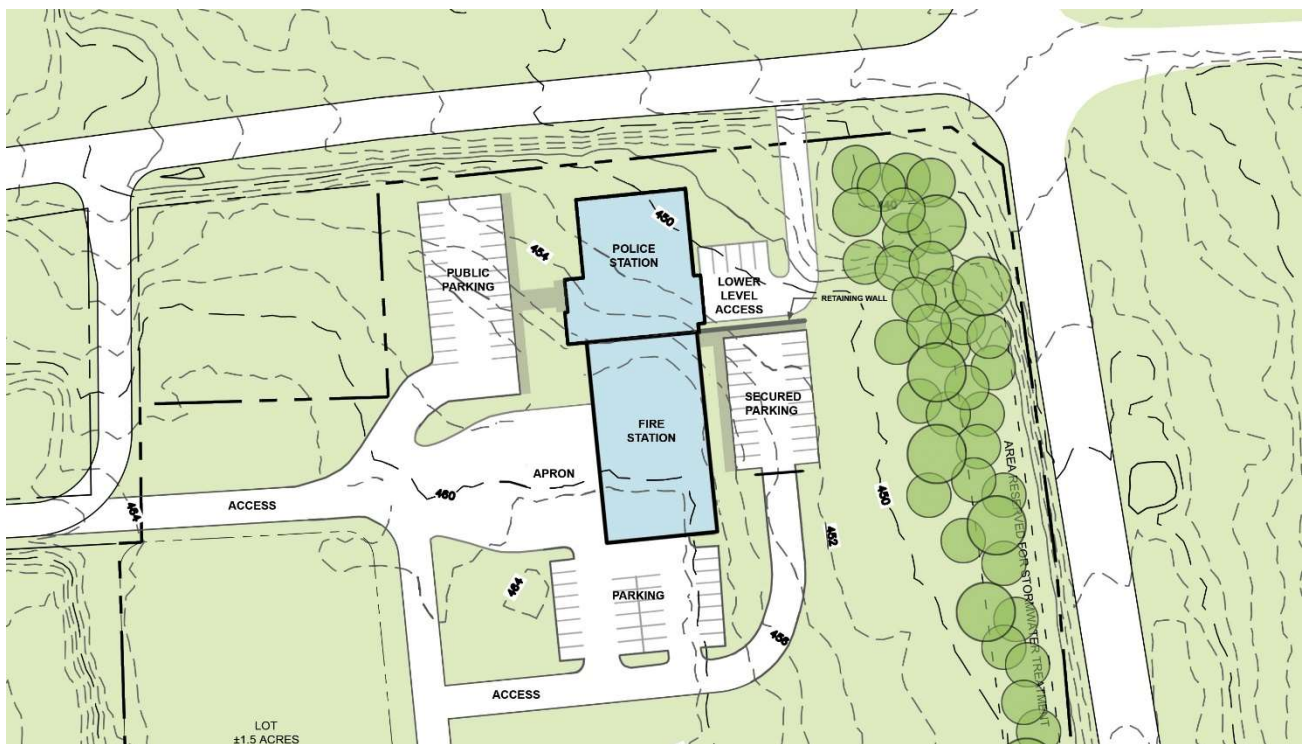
. Site Plan

The Consultants utilized the Birds Eye site to develop a plan for the Police Department facility as well as providing a more general plan for a public safety development on the site.

The Birds Eye site is an excellent site for the proposed police station. There is access to the two major roads which define the edges of the city, as they split just south of this site. The site is visible and accessible and provides adequate parking space and circulation as well as the required stand-off distances. It is not in a flood plain, nor is it in a residential neighborhood. Although the site has some slopes to the major frontage road, Route 1, the site itself is relatively flat.
