# Caribou Police Department

## Assessment

In January of 2020, the City of Caribou, Maine contracted with Artifex Architects and Engineers and with Public Safety Consulting Architect, Manns Woodward Studios (MWS) to perform a comprehensive assessment for the Caribou Police department. The scope of work addressed three primary areas of focus:

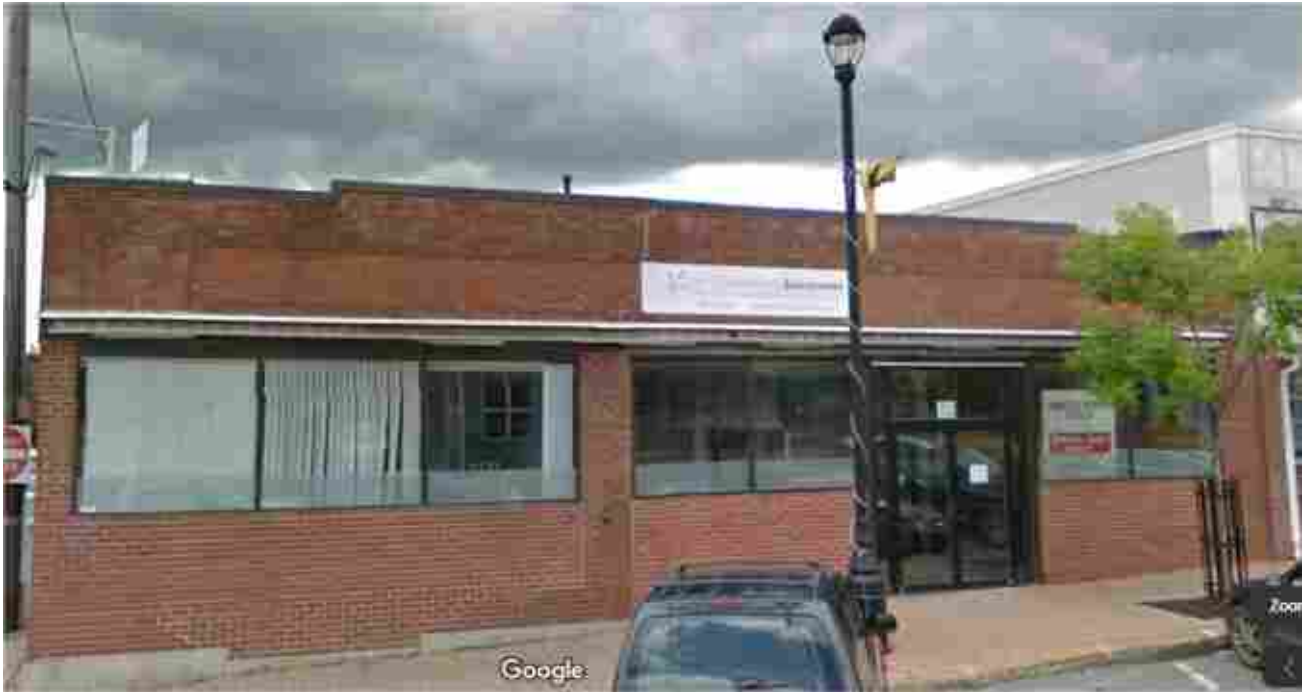
In general the deficiencies in structure would not align well with its usage as police facility, beginning with its inability to meet Category IV construction standards. The building, a single-story masonry structure with a flat roof has a full basement. The structure for the first floor is made up of 2"x12" floor joists, spanning from eighteen to twenty-six feet depending on the bay, cut to hang from composite beams created by gang nailing six 2"x12" with a 2"x4" cleat on each side. These beams spanned to 12"x12" wood posts of indeterminate age at approximately eighteen feet on center. There was no lateral support for the columns in any direction and no mechanical connection of columns to beams.

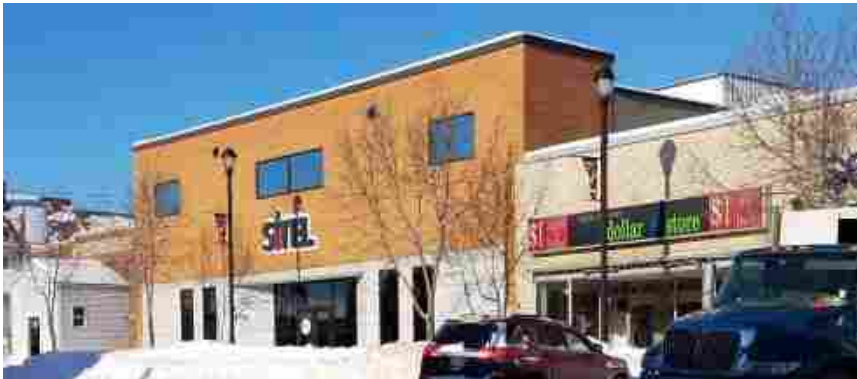
At first glance the building appears in good condition as the construction is steel and masonry, unlike the wood construction of the other options. Again, however, it is difficult to assess certain elements without destructive testing. But no bounciness or deflection at the second floor or roof was noted. There were signs of roof leakage at the second floor ceiling.

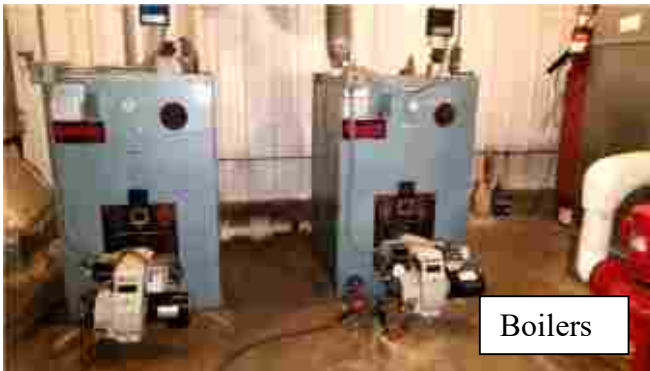
**Boilers**

The mechanical system for the building is a ducted forced air system which provides for both heating and air conditioning. The mechanical condensing units were on the roof with air handlers in a penthouse structure accessed by stairs from the second floor mechanical room which contained the building boilers. The oddest element of this system was the fuel storage and delivery: fuel was stored in a partially buried tank at the east side of the building on what appears to be the neighbor's property. It is located below a major exit from the building (one of three entries/exits and the only accessible entrance to the second floor). Diesel fuel, for the emergency generator, was also stored on site with a mini-storage area at the first floor of the building and pumps within the building, piping the fuel to the generator at the first floor rear of the building. The condition of this was hard to assess and the code compliance was also questionable.

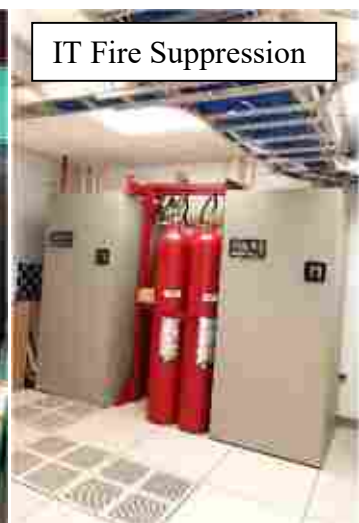
**IT Fire Suppression**

The building is also provided with a dedicated IT room with servers on a raised floor and fire suppression equipment.

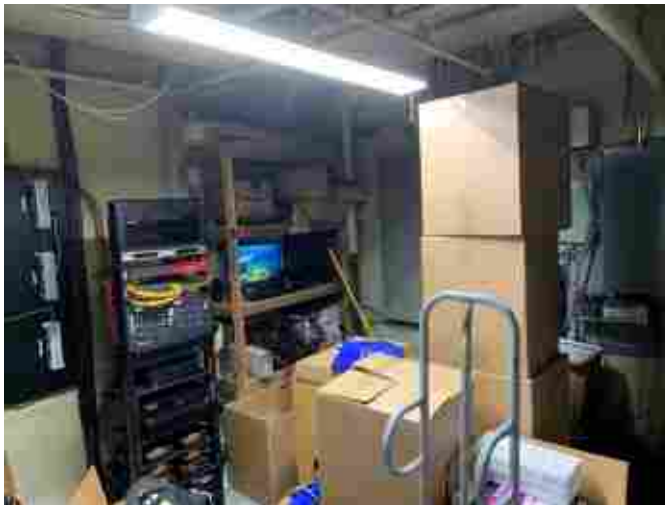
Photo electronics room (much wiring present) also used for storage:

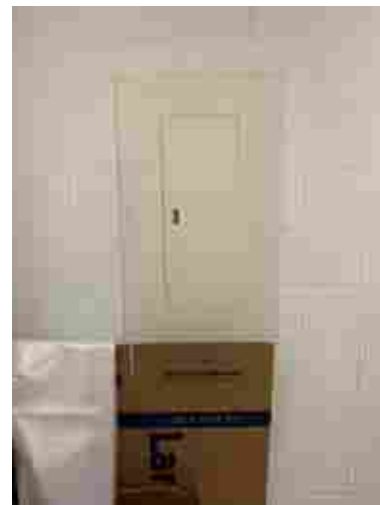
Photo of locked Electrical box

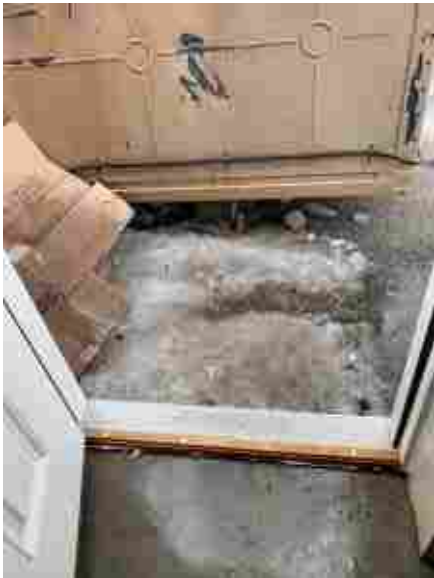
Photo of garage door discharge:

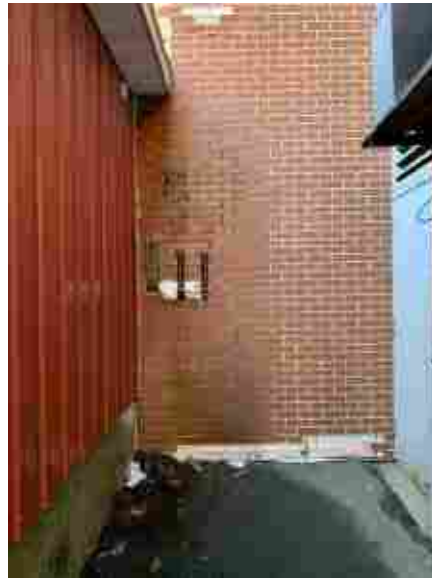
Area of 3/20/2019 "near miss":

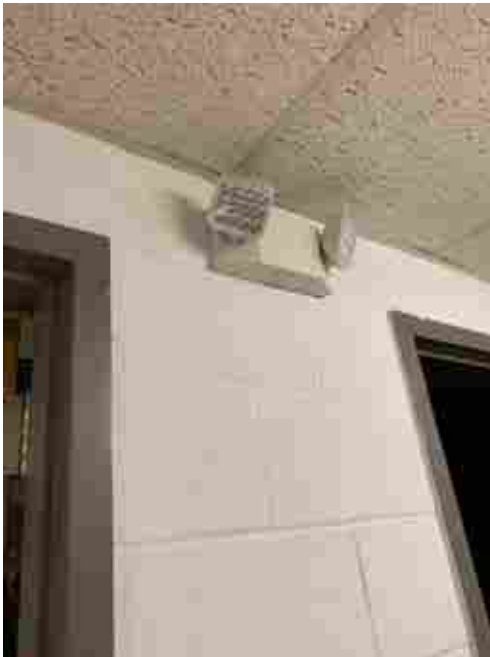
Photo of light that was not functional:

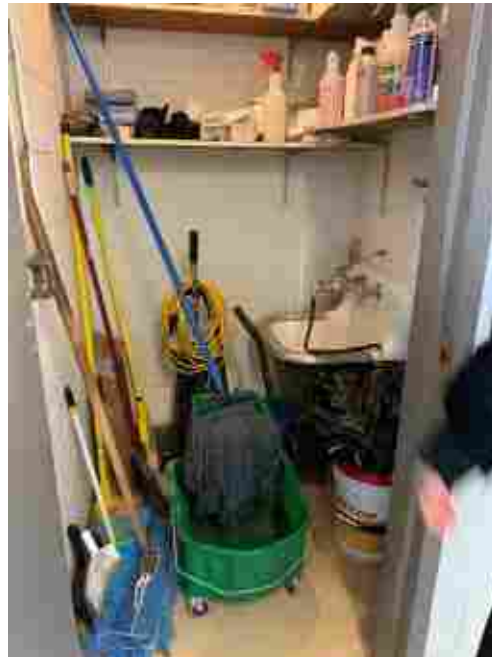
- Eye wash station is in janitor's closet

Eye wash station:

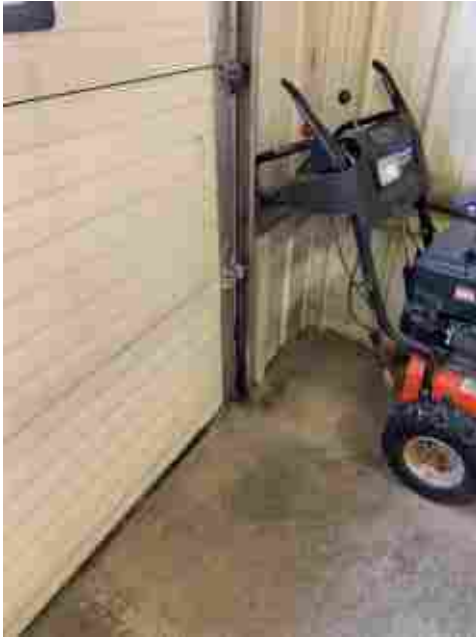
Lack of safety sensors on overhead doors:

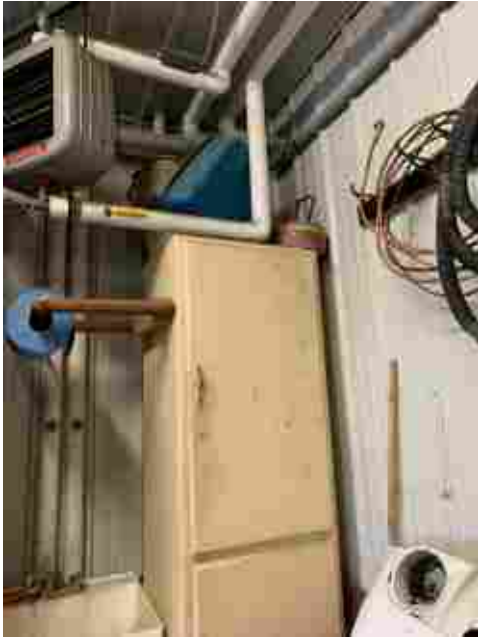
Property stored near heat source:

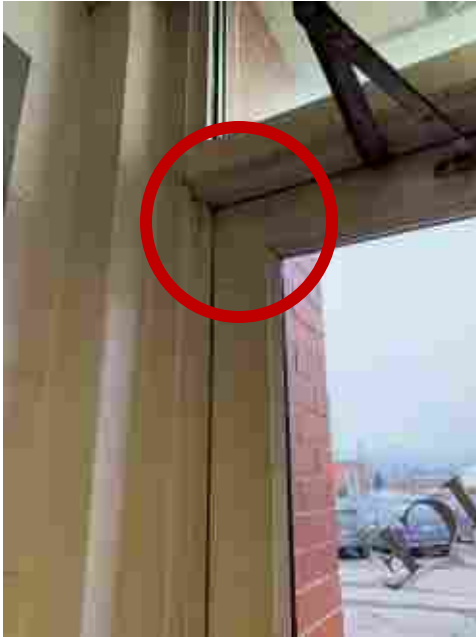
Daylight can be seen around front doors:

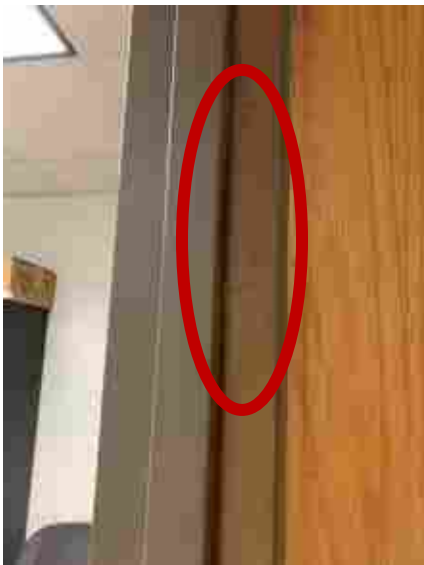
Door to municipal offices, rated assembly information painted over (below right):

NFPA 80 – 4.2.2 “Labels shall be applied in locations that are readily visible and convenient for identification after installation of the assembly.”
