Caribou Police Department

Assessment

In January of 2020, the City of Caribou, Maine contracted with Artifex Architects and Engineers and with Public Safety Consulting Architect, Manns Woodward Studios (MWS) to perform a comprehensive assessment for the Caribou Police department. The scope of work addressed three primary areas of focus:

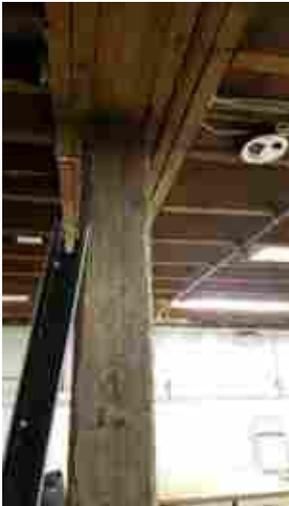
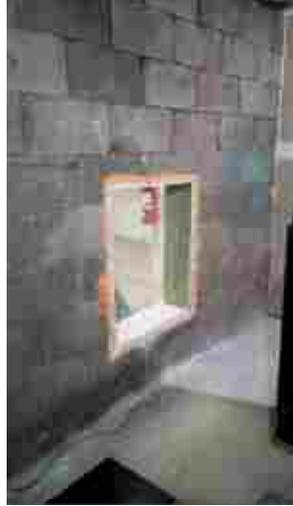
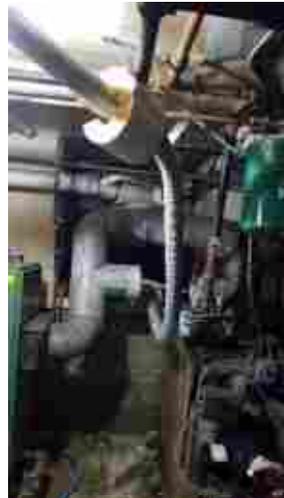
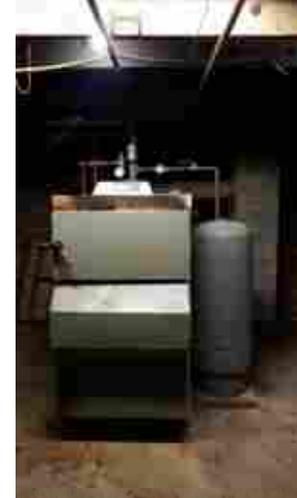
In general the deficiencies in structure would not align well with its usage as police facility, beginning with its inability to meet Category IV construction standards. The building, a single-story masonry structure with a flat roof has a full basement. The structure for the first floor is made up of 2"x12" floor joists, spanning from eighteen to twenty-six feet depending on the bay, cut to hang from composite beams created by gang nailing six 2"x12" with a 2"x4" cleat on each side. These beams spanned to 12"x12" wood posts of indeterminate age at approximately eighteen feet on center. There was no lateral support for the columns in any direction and no mechanical connection of columns to beams.

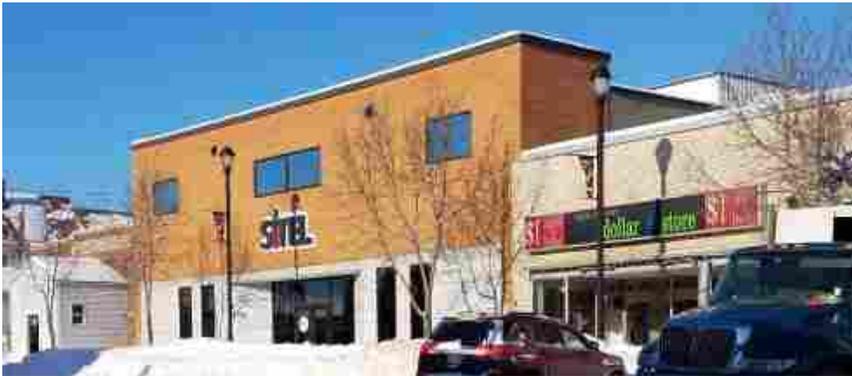
The building was obviously not originally designed as a police station or office use, but attempts have been made to configure it for office purposes. The major differences in commercial versus office is the need for daylight, as commercial sales usually require closed display areas with offices needing daylight for workers' health and satisfaction. The structural modifications to support the second floor use as call center entail new steel columns and beams with concrete structural floor. Many compromises would be required to accommodate City offices and police functions, one being the change from the quantity of daylight available in the current City hall versus the lack at the SITEL building. In addition, the Police Department would have to make major accommodations to make this building work as a police facility, if they are even possible; this does not make for an efficient plan or for efficient workflow.

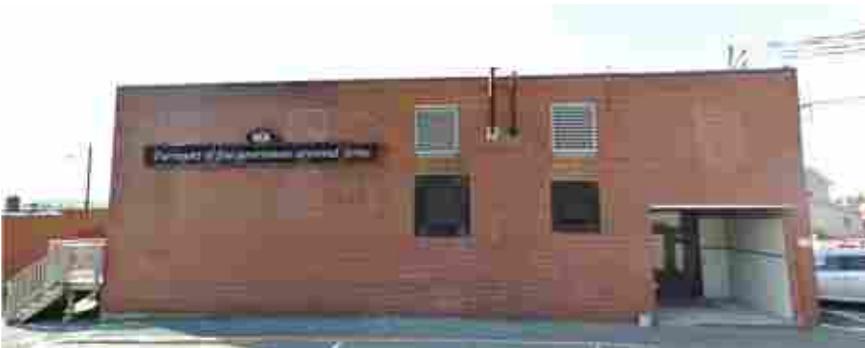
At first glance the building appears in good condition as the construction is steel and masonry, unlike the wood construction of the other options. Again, however, it is difficult to assess certain elements without destructive testing. But no bounciness or deflection at the second floor or roof was noted. There were signs of roof leakage at the second floor ceiling.

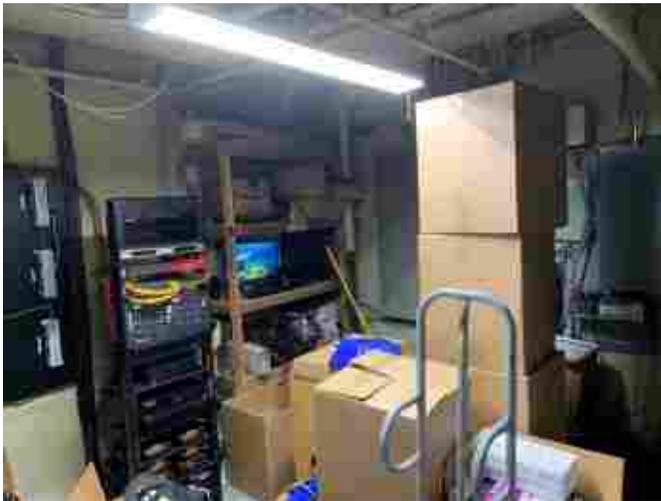
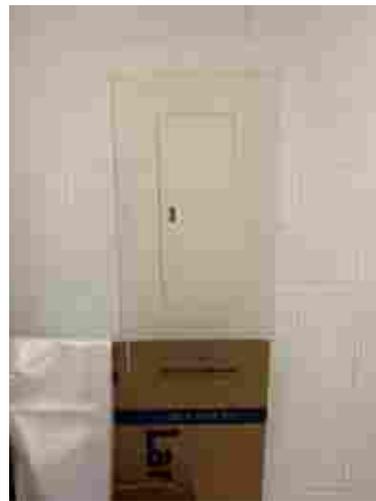
Photo electronics room (much wiring present) also used for storage:

Photo of locked Electrical box

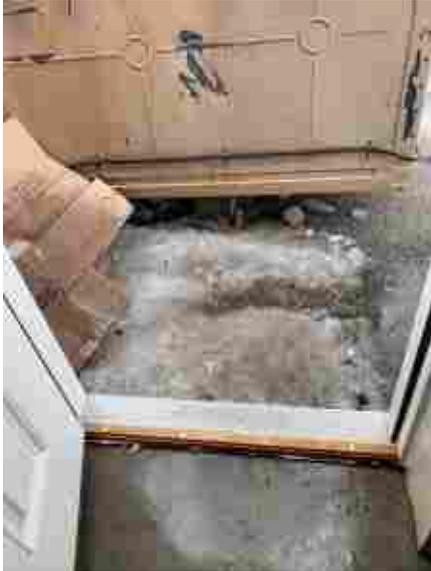
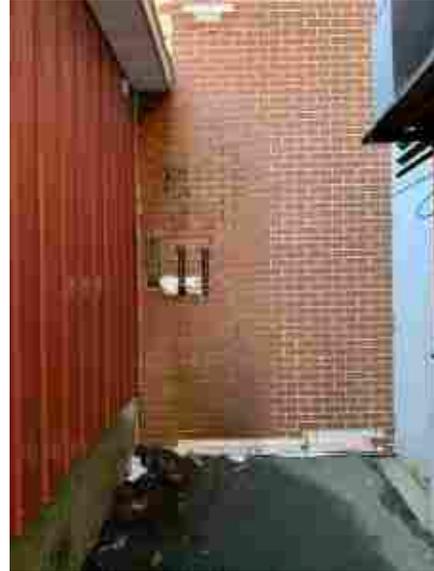
Photo of garage door discharge:

Area of 3/20/2019 "near miss":

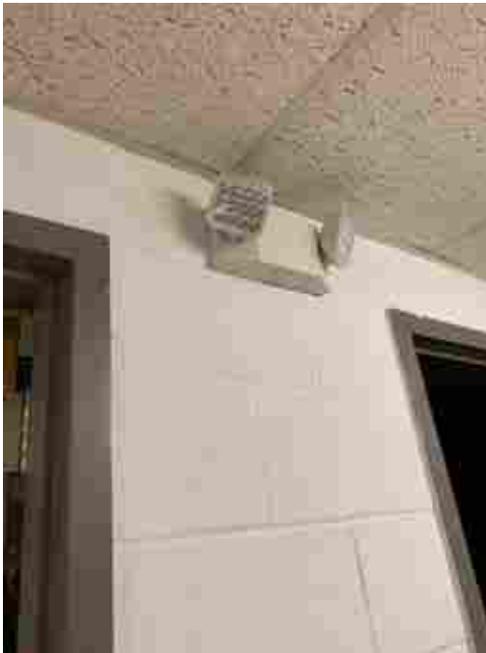
Photo of light that was not functional:

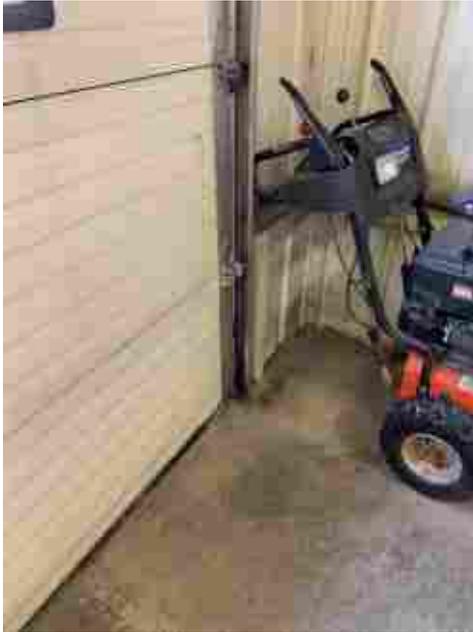
Lack of safety sensors on overhead doors:

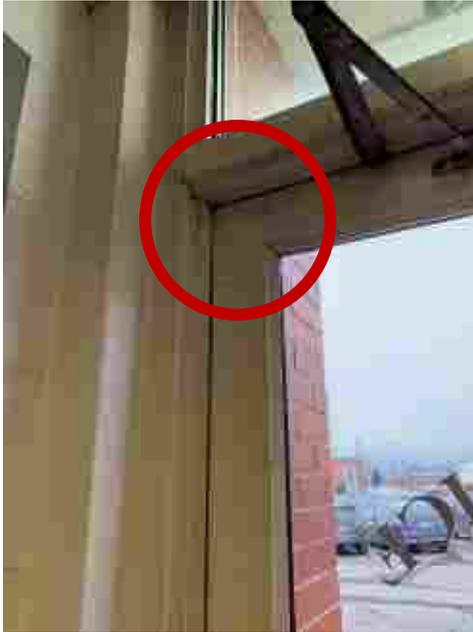
Daylight can be seen around front doors:

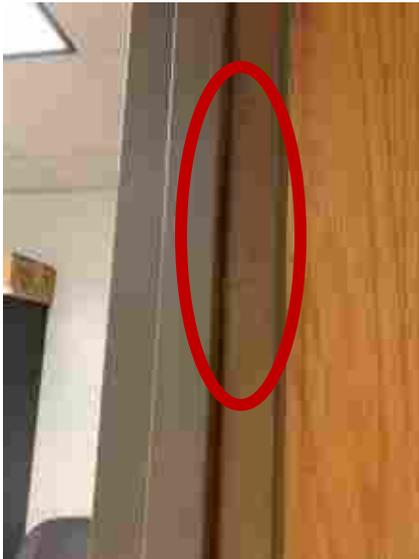
Door to municipal offices, rated assembly information painted over (below right):

NFPA 80 – 4.2.2 “Labels shall be applied in locations that are readily visible and convenient for identification after installation of the assembly.”
